# Systems Failure Anatomy of a Blackout

Course# EE420

**Technical Analysis of the  
August 14, 2003, Blackout:  
*What Happened, Why, and What Did We Learn?***

**Report to the NERC Board of Trustees  
by the NERC Steering Group**

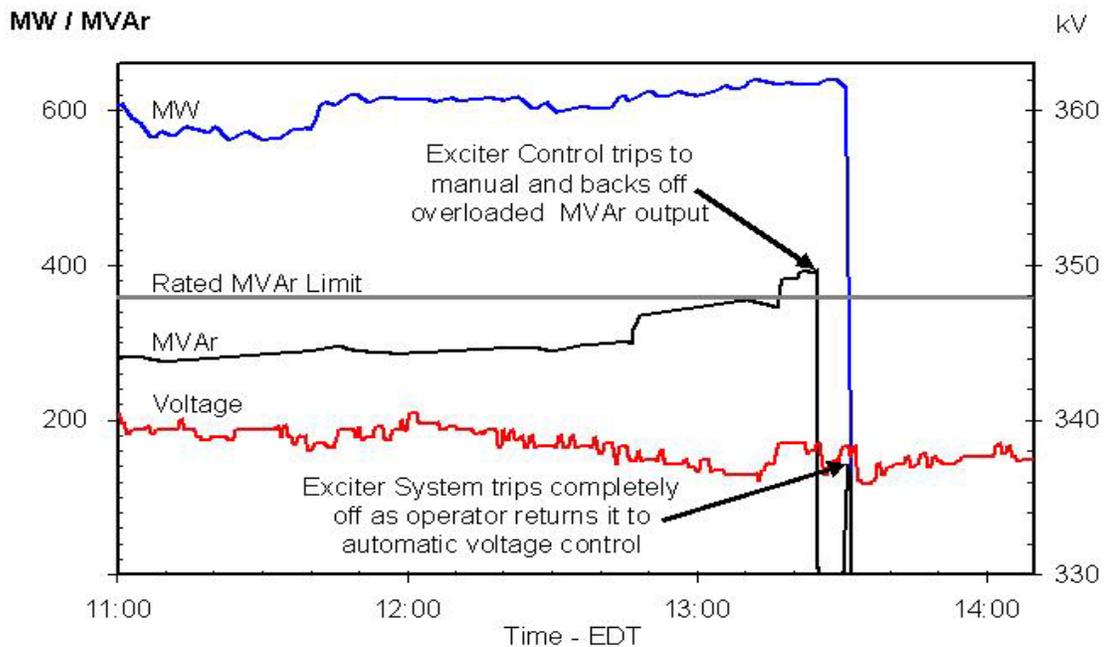
Figure III.1 — Eastlake 5 Output Prior to Trip at 13:31 EDT

About four or five minutes after the Mvar output decreased to zero, the operator was increasing the terminal voltage and attempting to place the exciter back on AVR control when the excitation system tripped altogether (see Figure III.1). The unit then tripped off at 13:31:34 when the loss of excitation relay operated. Later phone transcripts indicate subsequent trouble with a pump valve at the plant that would not re-seat after the trip. As a result, the unit could not be quickly returned to service.

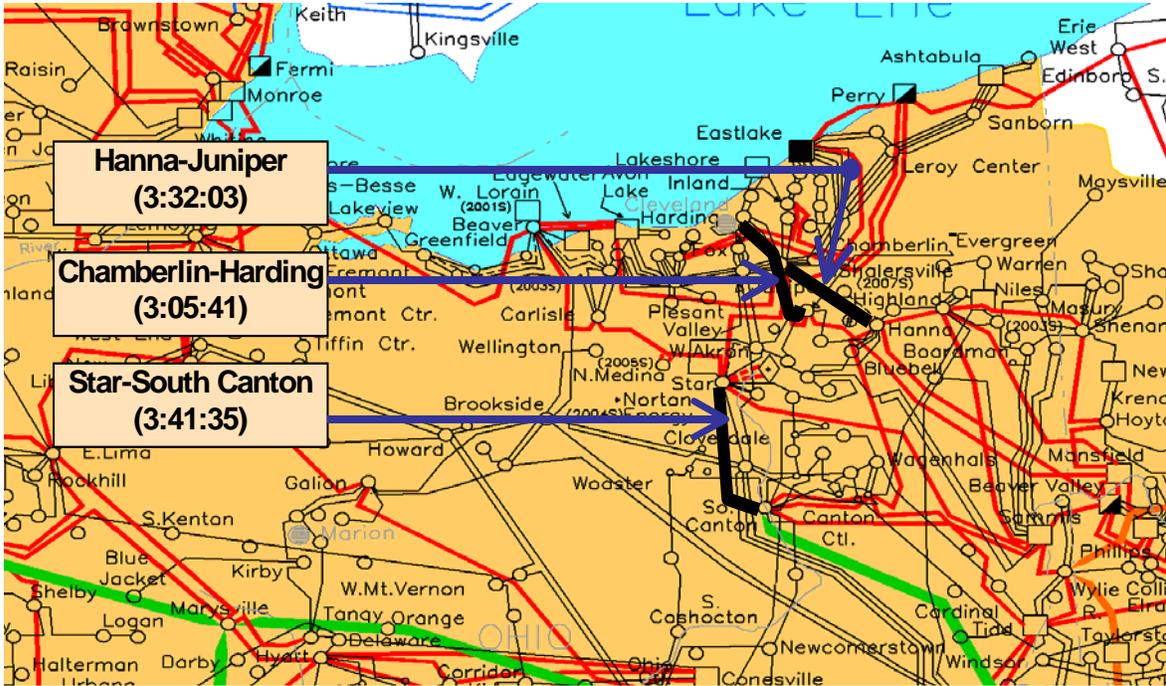
**Figure III.3 — Location of Three Line Trips**

Figure III.3 shows the location of the Chamberlin-Harding line and the two subsequent critical line trips.

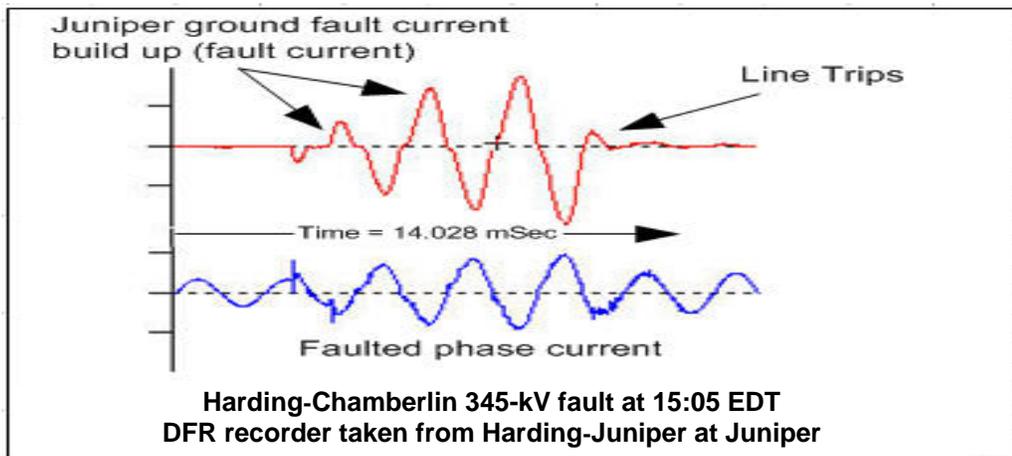
**Figure III.4 — Juniper DFR Indication of Tree Contact for Loss of the Chamberlin-Harding Line**

At 15:05:41, The FE Chamberlin-Harding 345-kV line tripped and locked out while loaded at 500 MVA or 43.5 percent of its normal and emergency ratings of 1,195 MVA (which are the same values). At 43.5 percent loading, the conductor temperature did not exceed its design temperature and the line could not have sagged sufficiently to allow investigators to conclude that the line sagged into the tree due to overload. Instead, investigators determined that FE had allowed trees in the Chamberlin-Harding right-of-way to grow too tall and encroach into the minimum safe clearance from a 345-kV energized conductor. The investigation team examined the relay data for this trip, which indicated high impedance Phase C fault-to-ground, and identified the geographic location of the fault. They determined that the relay data match the classic signature pattern for a tree-to-line fault (Figure III.4). Chamberlin-Harding tripped on directional ground relay — part of a directional comparison relay scheme protecting the line.

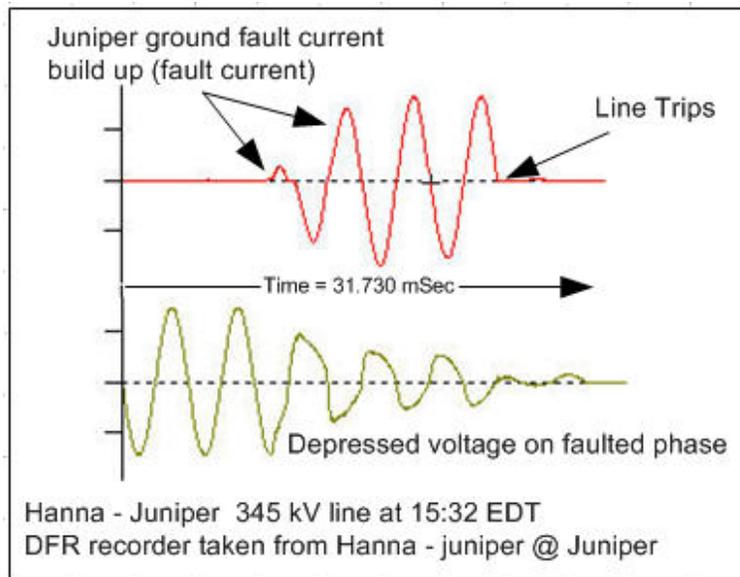
**Figure III.5 — Juniper DFR Indication of Tree Contact for Loss of Hanna-Juniper**

Incremental line current and temperature increases, escalated by the loss of Chamberlin-Harding, caused enough sag on the Hanna-Juniper line that it experienced a fault current due to tree contact, tripped and locked out at 15:32:03, with current flow at 2,050 amperes or 87.5 percent of its normal and emergency line rating of 2,344 amperes. Figure III.5 shows the Juniper digital fault recorder indicating the tree signature of a high-impedance ground fault. Analysis showed high arc resistance limiting the actual fault current well below the calculated fault current assuming a "bolted" (no arc resistance) fault.

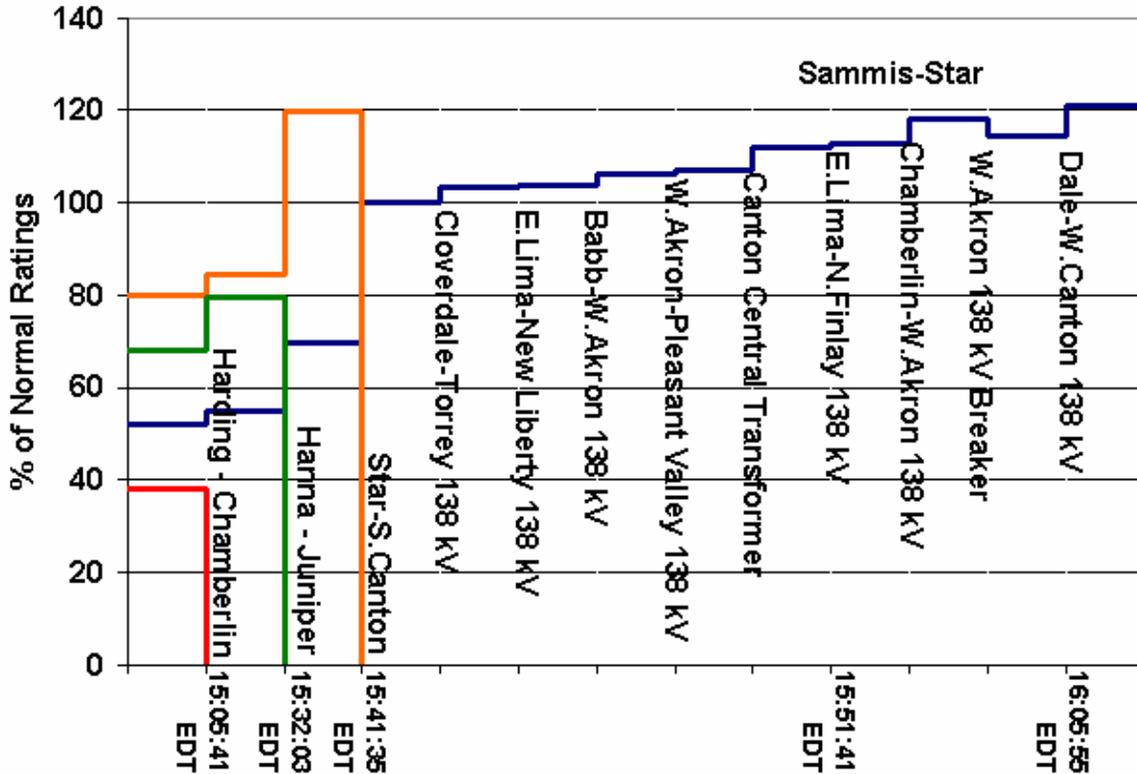
Figure III.6 — Line Loadings as the Northeast Ohio 345-kV Lines Trip

Figure III.6 shows the line loadings calculated by the investigation team as the 345-kV lines in northeast Ohio began to trip. Showing line loadings on the 345-kV lines as a percent of normal rating, the graph tracks how the loading on each line increased as each subsequent 345-kV and 138-kV line tripped out of service between 15:05 (Chamberlin-Harding) and 16:06 (Dale-West Canton). As the graph shows, none of the 345- or 138-kV lines exceeded their normal ratings on an actual basis (although contingency overloads existed) until after the combined trips of Chamberlin-Harding and Hanna-Juniper. But immediately after Hanna-Juniper was lost, Star-South Canton's loading jumped from an estimated 82 percent of normal to 120 percent of normal (still below its emergency rating) and remained at that level for ten minutes before tripping out. To the right, the graph shows the effects of the 138-kV line failures (discussed next) on the remaining 345-kV line, i.e., Sammis-Star's loading increased steadily above 100 percent with each succeeding 138-kV line lost.

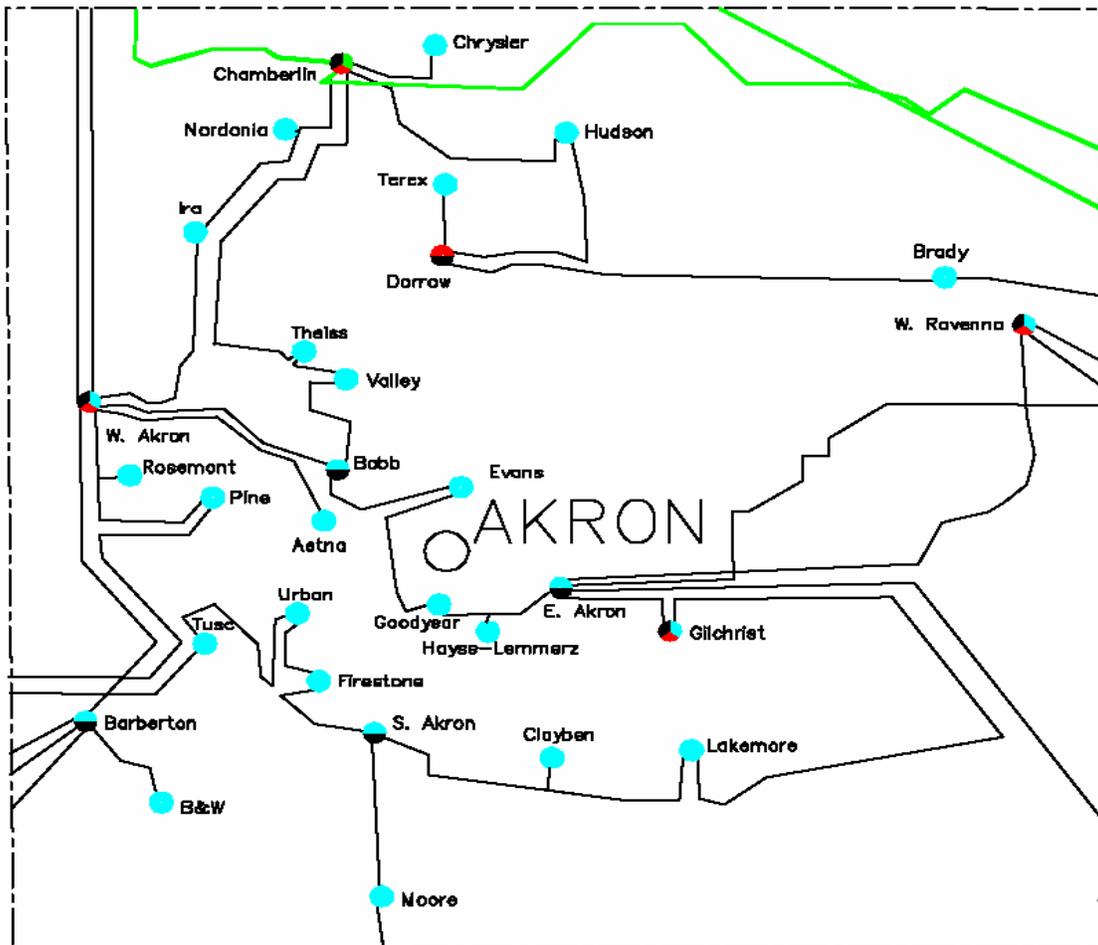
Figure III.7 — Akron Area Substations Participating in Localized 138-kV Cascade

Approximately 600 MW of customer loads were shut down in Akron and areas to the west and south of the city during the cascade because they were being served by transformers connected to those lines. As the lines failed, severe voltage drops caused a number of large industrial customers with voltage-sensitive equipment to go off-line automatically to protect their operations.

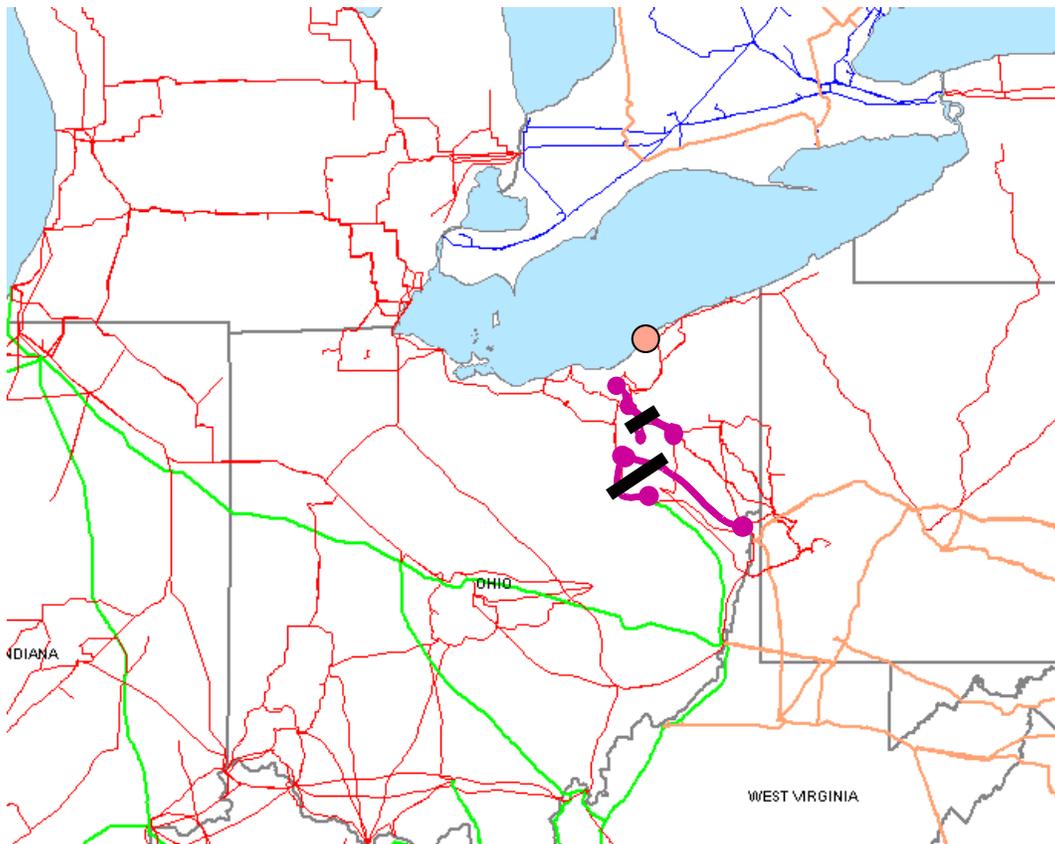
**Figure III.8 — Cleveland-Akron Cut Off**

As shown in Figure III.8, the Sammis-Star line trip completely severed the 345-kV path into northern Ohio from southeast Ohio, triggering a new, fast-paced sequence of 345-kV transmission line trips in which each line trip placed a greater flow burden on those lines remaining in service. After Sammis-Star tripped, there were only three paths left for power to flow into northern Ohio: (1) from northwestern Pennsylvania to northern Ohio around the south shore of Lake Erie, (2) from southern Ohio, and (3) from eastern Michigan and Ontario. Northeastern Ohio had been substantially weakened as a source of power to eastern Michigan, making the Detroit area more reliant on 345-kV lines west and northwest of Detroit, and from northwestern Ohio to eastern Michigan.

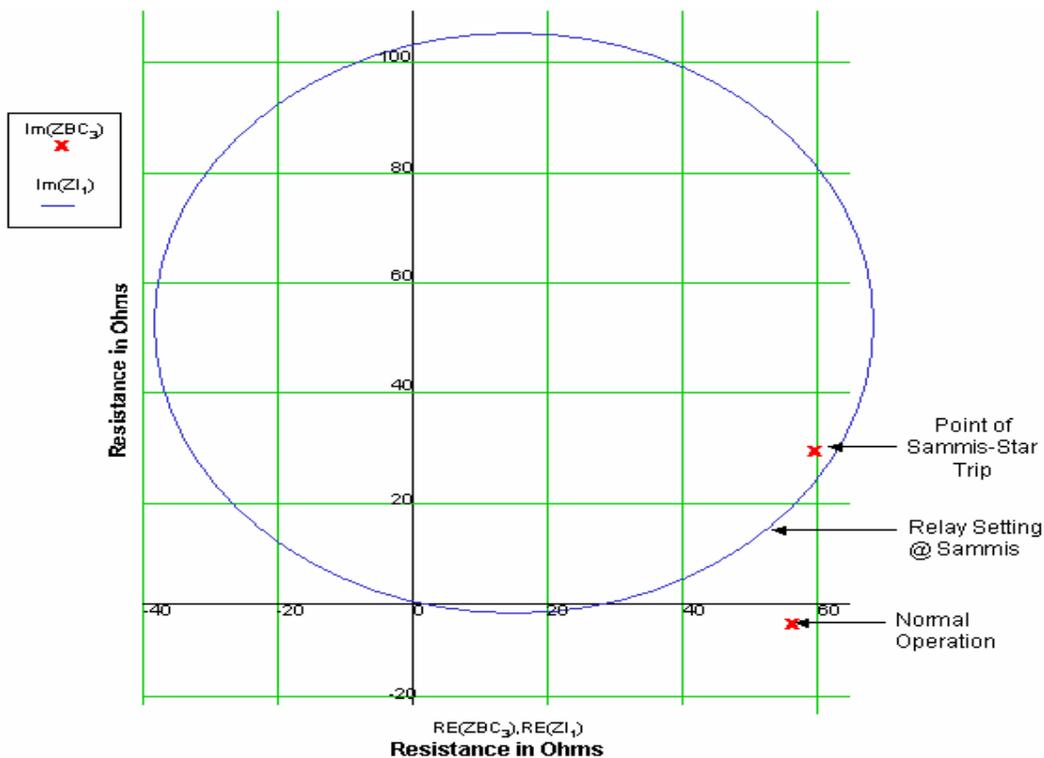
**Figure III.9 — Load Encroachment of Sammis-Star Zone 3 Impedance Relay**

A zone 3 relay can be defined as an impedance relay that is set to detect system faults on the protected transmission line and beyond.<sup>5</sup> It sometimes serves a dual purpose. It can act through a timer to see faults beyond the next bus up to and including the furthest remote element attached to the bus. It is used for equipment protection beyond the line and it is an alternative to equipment failure communication systems sometimes referred to as breaker failure transfer trip. Zone 3 relays can also be used in the high-speed relaying system for the line. In this application, the relay needs directional intelligence from the other end of the line that it receives via a highly reliable communication system. In the Sammis-Star trip, the zone 3 relay operated because it was set to detect a remote fault on the 138-kV side of a Star substation transformer in the event of a breaker failure.

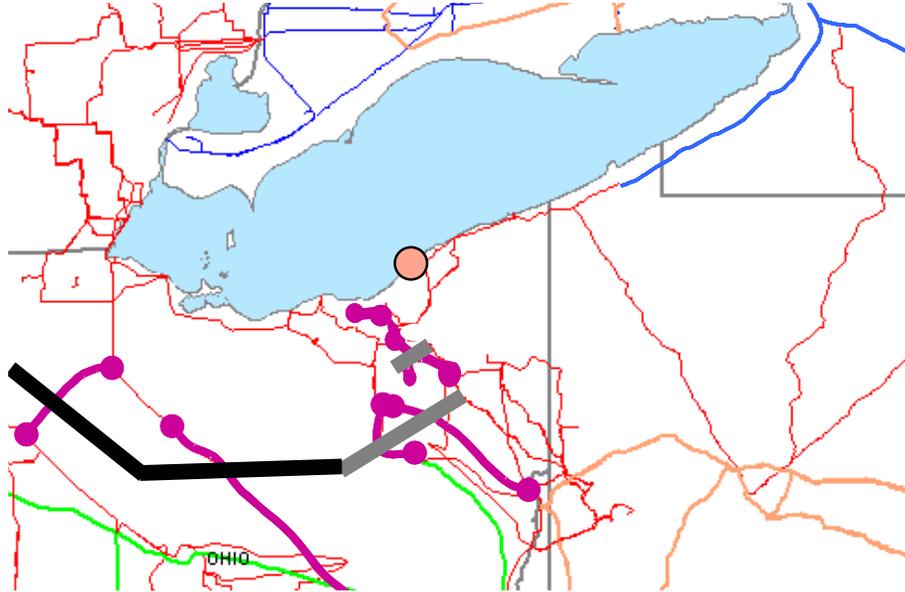
**Figure IV.7 — Ohio 345-kV Lines Trip, 16:08:59 to 16:09:07**

numerous 138-kV line trips in central Ohio, the East Lima-Fostoria Central line tripped at 16:09:06 on zone 3 relay operation due to high current and low voltage (80 percent). Modeling indicates that if automatic under-voltage load-shedding had been in place in northeastern and central Ohio, it might have been triggered at or before this point and dropped enough load to reduce or eliminate the subsequent line overloads that spread the cascade. The line trips across Ohio are shown in figure IV.7.

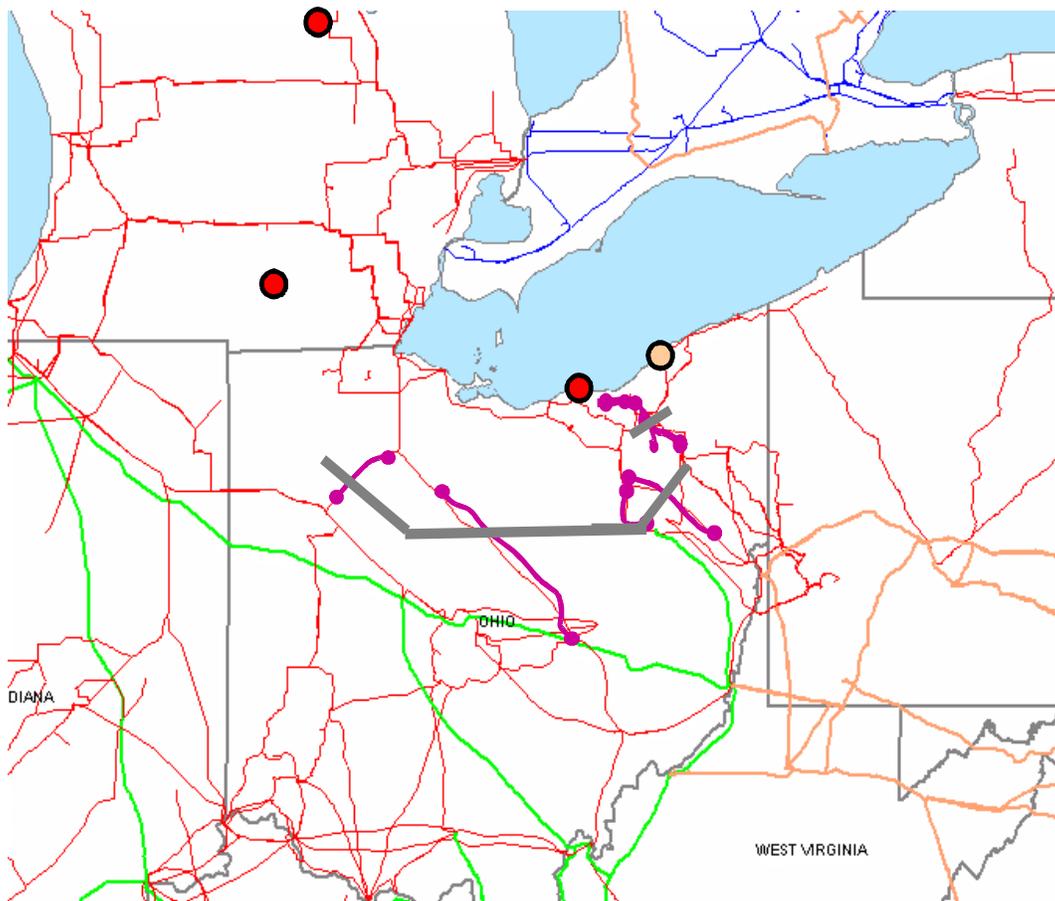
Figure IV.11 — Michigan and Ohio Power Plants Trip or Run Back

The MCV plant in central Michigan experienced a 300 MW run-back. The Avon Lake 7 unit tripped due to the loss of the voltage regulator. The Burger units tripped after the 138-kV lines from the Burger 138-kV generating substation bus to substations in Ohio tripped from high reactive power flow due to the low voltages in the Cleveland area. Three units at the Kinder Morgan generating station in south-central Michigan tripped due to a transformer fault and over-excitation.
