Chemical Deicers & Concrete Pavement: Impacts & Mitigation

One (1) Continuing Education Hour
Course #CV1212

CHEMICAL DEICERS AND CONCRETE PAVEMENT: IMPACTS AND MITIGATION

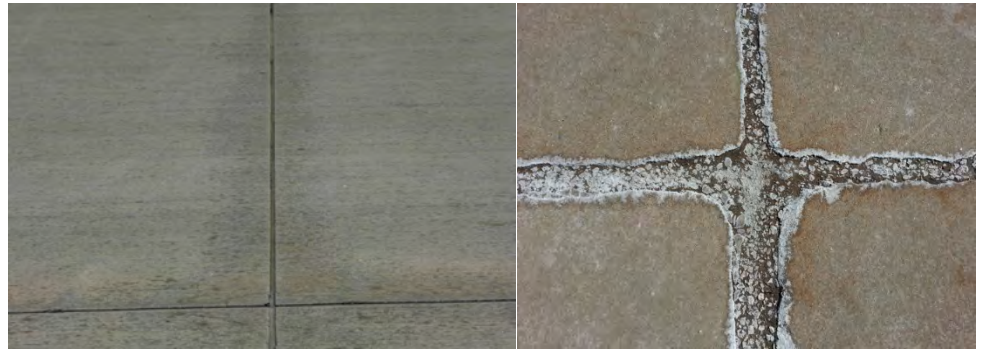
Figure 1. Joint “shadowing” (left) and eventual disintegration of concrete at joint (right).

However, there has been a recent increase in deterioration observed in the vicinity of concrete joints. As illustrated in figure 1 (presented earlier), this distress differs from scaling in that it initiates and progresses at joint locations. It often first appears as a “darkening” or “shadowing” of the concrete adjacent to the joint, which is attributed to water being trapped in microcracks that have developed near the joints. Over time, this microcracking may progress into significant loss of material (Taylor, Sutter, and Weiss 2012; Weiss and Farnam 2015). Physical mechanisms of this joint deterioration have been linked to the following factors, often working in combination (Taylor, Sutter, and Weiss 2012):

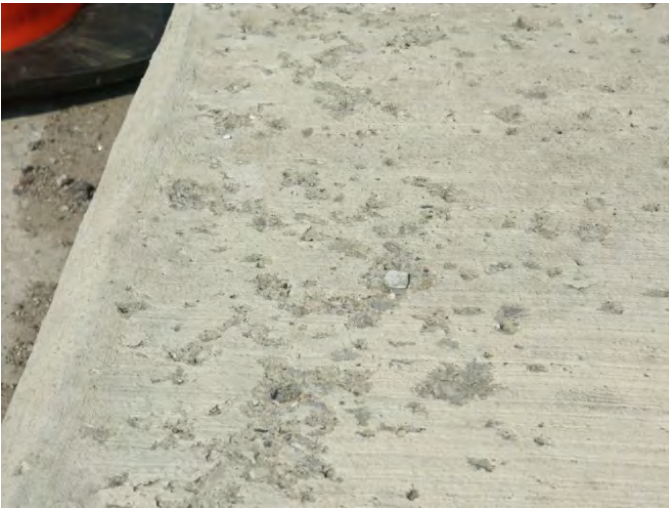
Figure 3. Concrete surface suffering deicer scaling.

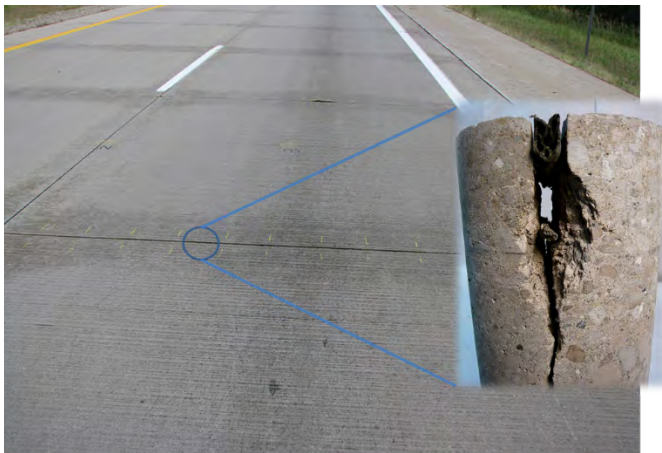
Figure 5. Joints on I-94 in Michigan showing surface "shadowing." Extracted core reveals high degree of damage below the surface in zone of high degree of saturation (courtesy Dr. Karl Peterson).

Once the water-salt solution pools within the joint, it is absorbed into the exposed concrete and becomes increasingly concentrated over time as additional deicing salts are used (Jones et al. 2013; Weiss and Farnam 2015; Monical et al. 2016). If the joint is not draining, the greatest degree of saturation occurs in a zone at the bottom of the first saw cut, as shown in figure 4b. Due in part to the properties of salt solutions, which increase the degree of saturation, this may result in the concrete within this zone exceeding critical saturation (Jones et al. 2013; Monical et al. 2016). Figure 5 illustrates the type of damage that can occur in this zone of critically high saturation.

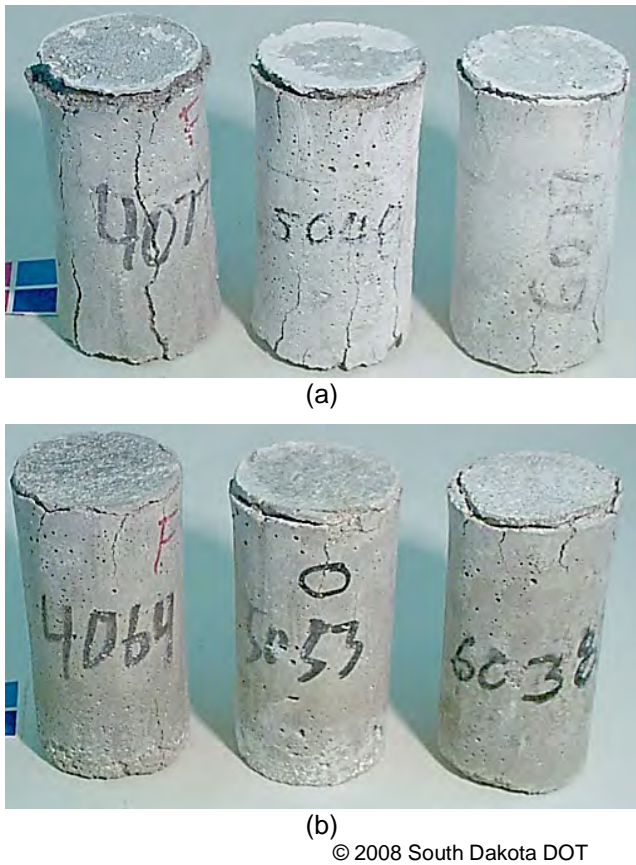
Figure 6. Expansion in mortar specimens soaked in (a) CaCl_2 and (b) MgCl_2 for 84 days at 40 °F. Note that these specimens were never frozen (Sutter et al. 2008).
