# Systems Failure Anatomy of a Blackout

Course# EE420

**Technical Analysis of the  
August 14, 2003, Blackout:  
*What Happened, Why, and What Did We Learn?***

**Report to the NERC Board of Trustees  
by the NERC Steering Group**

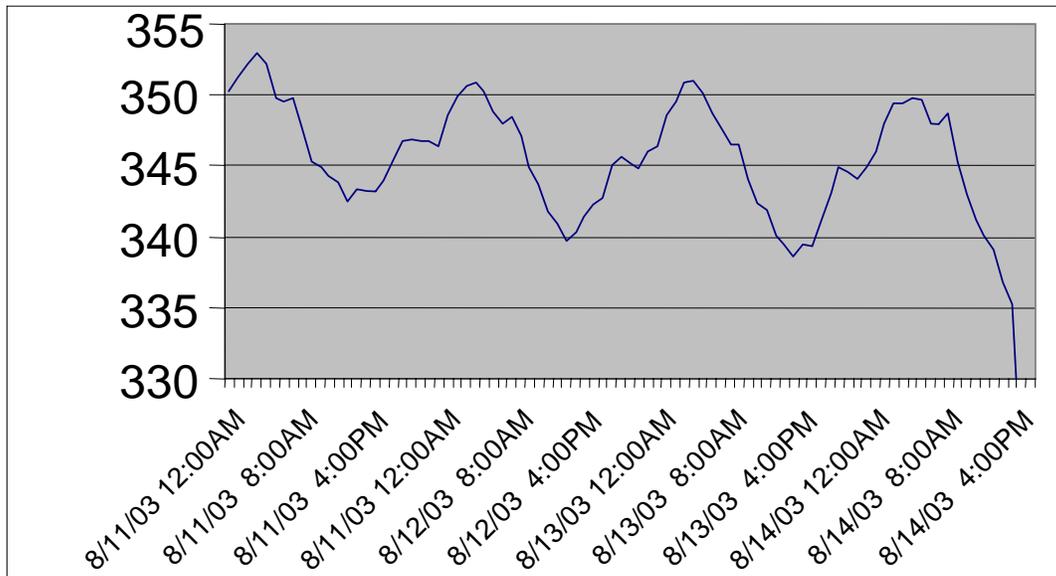
**Figure II.6 — Representative Voltage Profile on FE System during Week of August 11**

- The voltage profiles in both west-to-east and north-to-south directions display a dip at the center, with FE critical buses in the Cleveland-Akron area forming a low voltage cluster at Avon Lake, Harding, Juniper, Chamberlin, and Star.
- Voltages were observed to be higher in the portions of the FE control area outside of the Cleveland-Akron area. Voltages bordering FE in adjacent control areas were observed to be higher still. The bus voltages outside the Cleveland-Akron area are consistently higher during the period leading up to August 14.

- The bus voltages in the Cleveland-Akron area show a greater decline as the week progressed compared to buses outside this area.

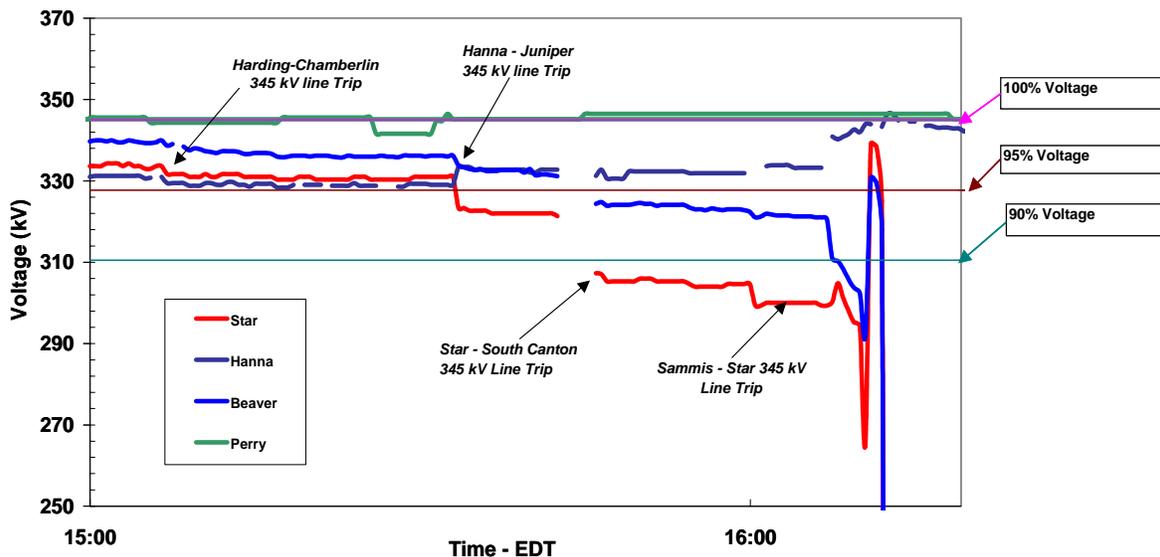
**Figure II.7 — 345-kV Voltages in Northeastern Ohio on August 14, 2003**

The existence of low voltages in northern Ohio is consistent with the patterns of power flow and composition of load on August 14. The power flow patterns for the region just before the Chamberlin-Harding line tripped at 15:05 show that FE was a major importer of power. Air-conditioning loads in the metropolitan areas around the southern end of Lake Erie were also consuming reactive power (Mvar). The net effect of the imports and load composition was to depress voltages in northern Ohio. Consistent with these observations, the analysis of reactive power flow shows that northern Ohio was a net importer of reactive power.

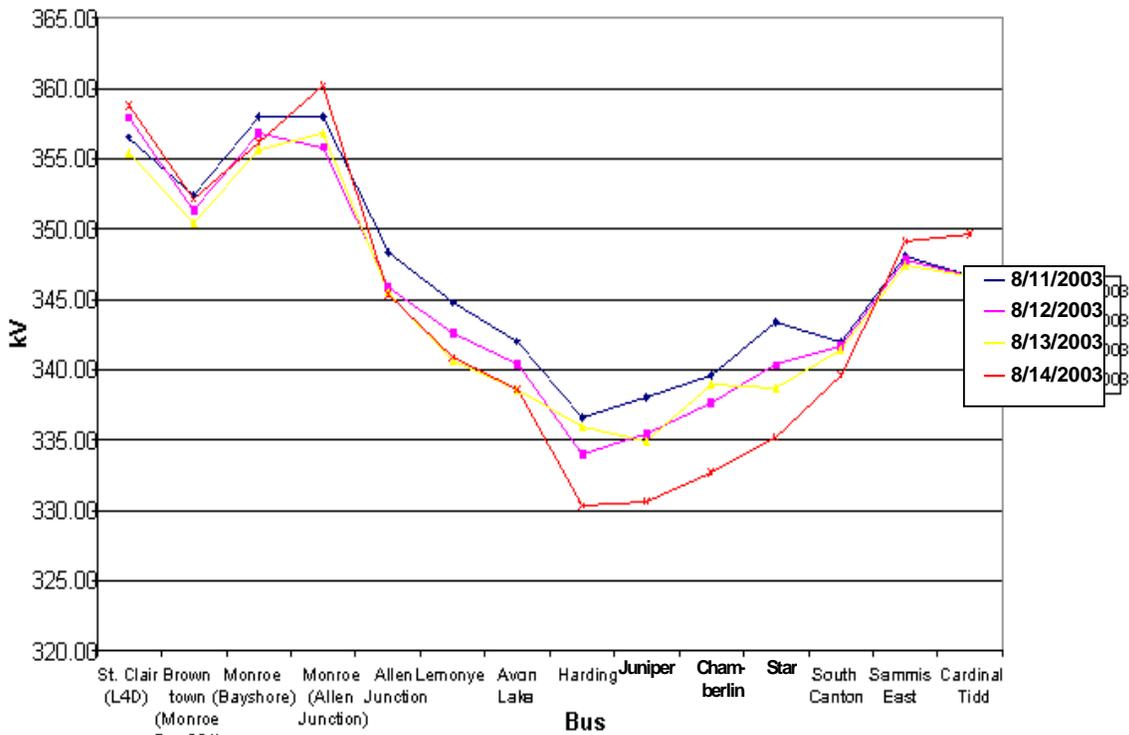
Figure II.9 — North-to-South Voltage Profile

Analysis showed that the declining voltages in the Cleveland-Akron area were strongly influenced by the increasing temperatures and loads in that area and minimally affected by transfers through FE to other systems. FE did not have sufficient reactive supply in the Cleveland-Akron area on August 14 to meet reactive power demands and maintain a safe margin from voltage collapse.

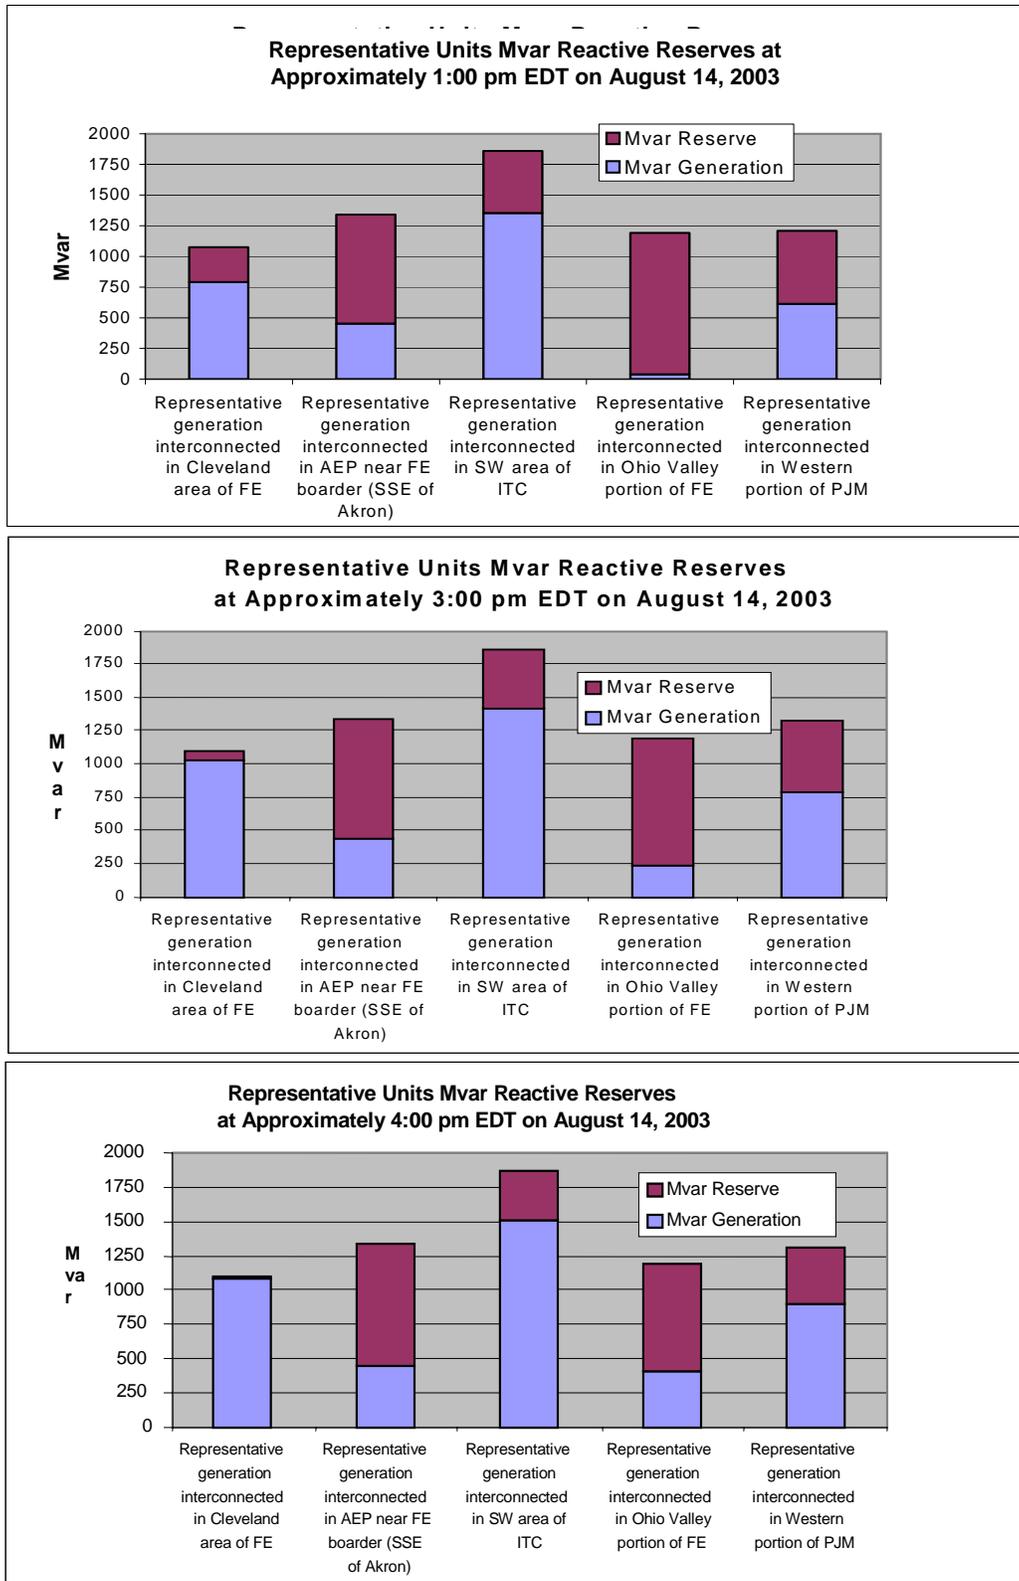
**Figure II.10 — Reactive Reserves of Representative Groups of Generators on August 14, 2003**

Figure II.10 shows the actual reactive power reserves from representative generators along the Lake Erie shore and in the Cleveland-Akron area for three time periods on August 14. It also shows the reactive power reserves from representative generators in AEP, MECS, and PJM that are located in the proximity of their interconnections with FE.

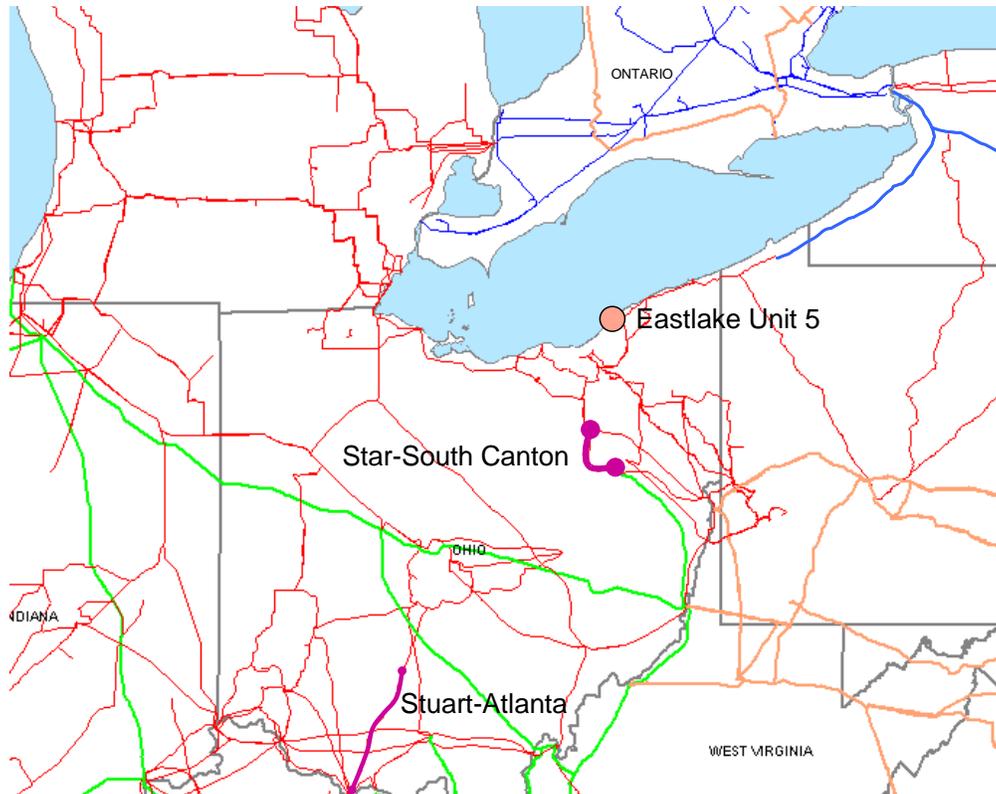
Figure III.2 — Initial Events

At 14:27:16, while loaded at about 54 percent of its emergency ampere rating, the Star-South Canton 345-kV tie line (between AEP and FE) tripped and successfully reclosed. The digital fault recorder indicated a solid Phase C-to-ground fault near the FE Star station. The South Canton substation produced an alarm in AEP’s control room. However, due to the FE computer alarm system failure beginning at 14:14, the line trip and reclosure at FE Star substation were not alarmed at the FE control center. The FE operators had begun to lose situational awareness of events occurring on their system as early as 14:27, when the Star-South Canton line tripped momentarily and reclosed. Figure III.2 presents the initial events: the Eastlake 5 trip, the Stuart-Atlanta trip, and the Star-South Canton trip and reclose.

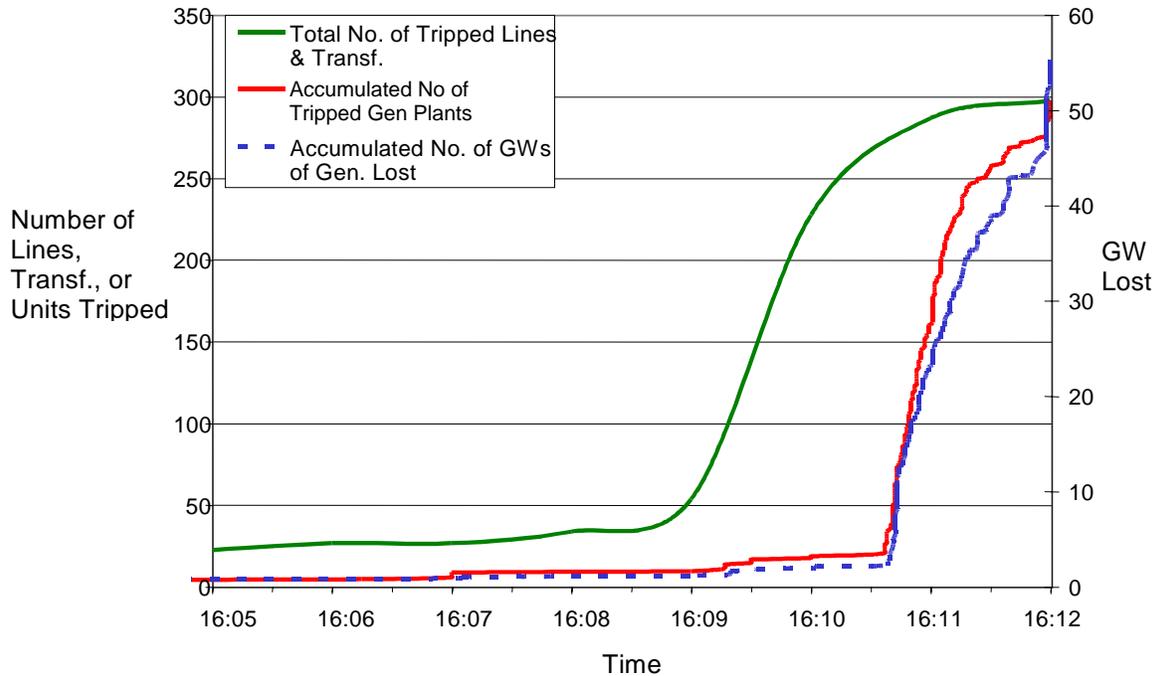
**Figure IV.1 — Accumulated Line and Generator Trips During the Cascade**

The events in the cascade started slowly, but spread quickly. Figure IV.1 illustrates how the number of lines and generators lost stayed relatively low during the Ohio phase of the blackout, but then picked up speed after 16:08:59. The cascade was complete only two-and-one-half minutes later.

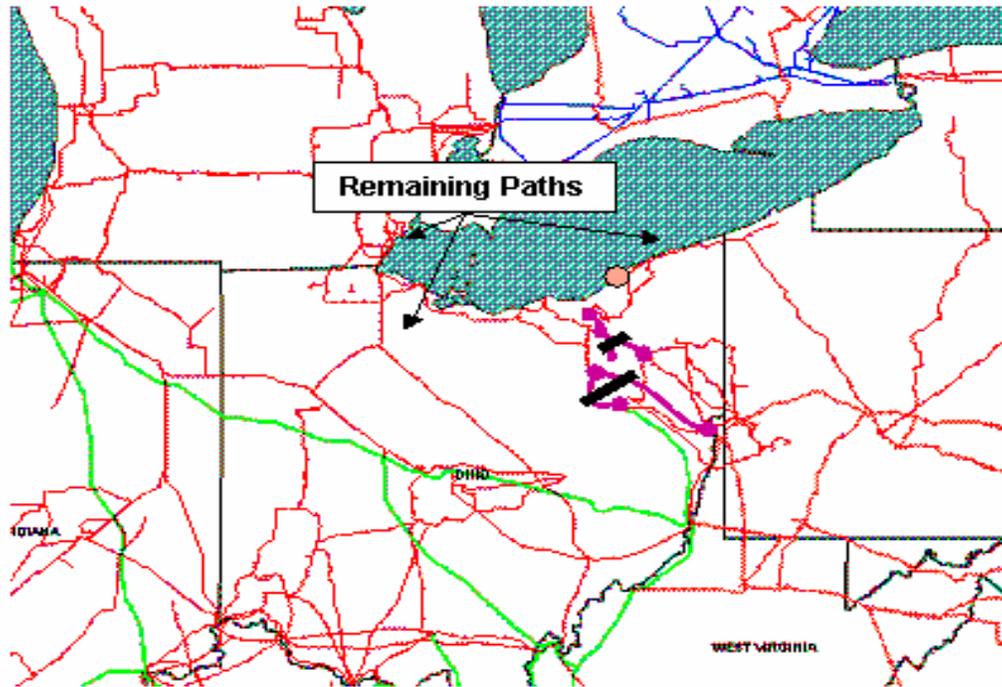
**Figure IV.3 — Sammis-Star 345-kV Line Trip 16:05:57**

After the loss of Sammis-Star and the underlying 138-kV system, there were no large capacity transmission lines left from the south to support the significant amount of load in northern Ohio (Figure IV.3). This overloaded the transmission paths west and northwest into Michigan, causing a sequential loss of lines and power plants.

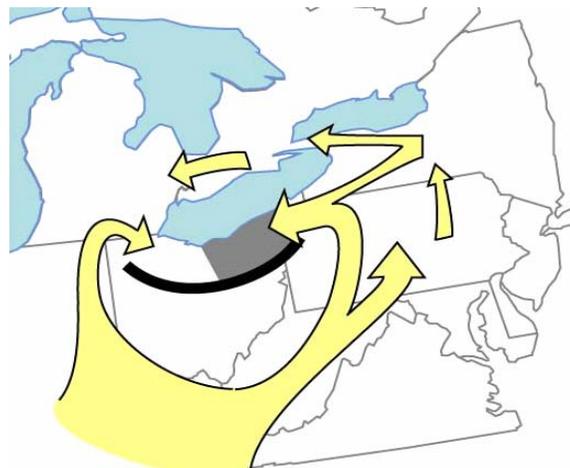
**Figure IV.8 — Power Flows at 16:09:25**

The tripping of the Galion-Ohio Central-Muskingum and East Lima-Fostoria Central transmission lines removed the transmission paths from southern and western Ohio into northern Ohio and eastern Michigan. Northern Ohio was connected to eastern Michigan by only three 345-kV transmission lines near the southwestern bend of Lake Erie. Thus, the combined northern Ohio and eastern Michigan load centers were left connected to the rest of the grid only by: (1) transmission lines eastward from northeastern Ohio to northwestern Pennsylvania along the southern shore of Lake Erie, and (2) westward by lines west and northwest of Detroit, Michigan, and from Michigan into Ontario (Figure IV.8).

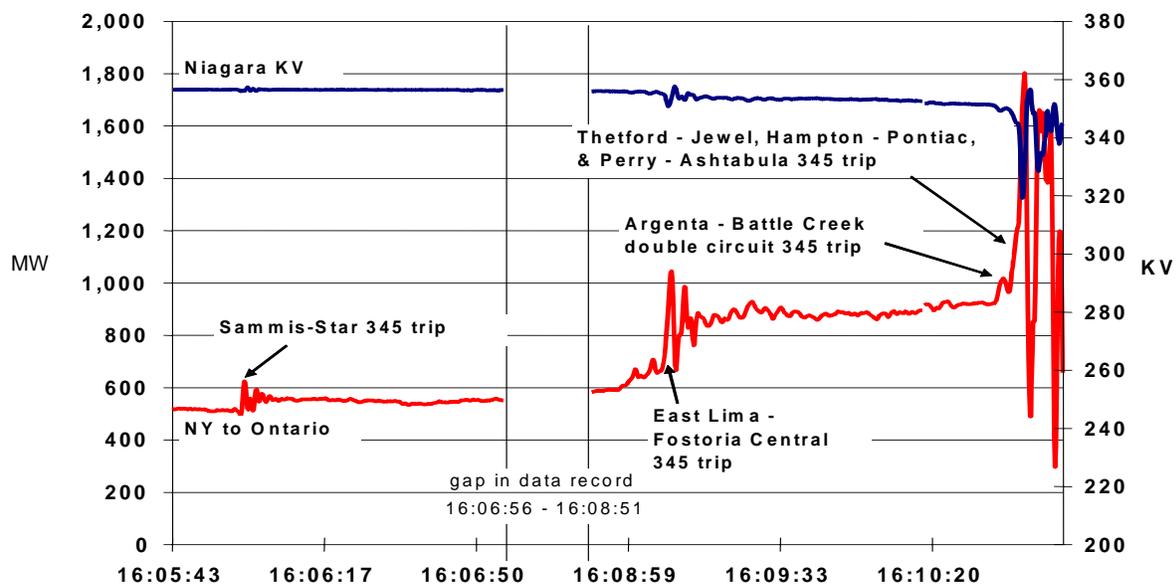
Figure IV.9 — New York-Ontario Line Flows at Niagara

Figure IV.9 shows voltage levels recorded in the Niagara area. It shows that voltage levels remained stable until about 16:10:30, despite significant power fluctuations. In the cascade that followed, the voltage instability was a companion to, not a driver of, the angular instability that tripped generators and lines. A high-speed recording of 345-kV flows at Niagara Falls taken by the Hydro One recorders (shown as the lower plot in Figure IV.9), shows the impact of the East Lima-Fostoria Central and the New York-to-Ontario power swing, which continued to oscillate for more than ten seconds. Looking at the MW flow plot, it is clear that when Sammis-Star tripped, the system experienced oscillations that quickly damped out and rebalanced. But East Lima-Fostoria triggered significantly greater oscillations that worsened in magnitude for several cycles, and then dampened more slowly but continued to oscillate until the Argenta-Battle Creek trip 90 seconds later. Voltages also began to decline at that time.

The far right side of Figure IV.9 shows the fluctuations in flows and voltages at the New York-Ontario Niagara border triggered by the trips of the Argenta-Battle Creek, Argenta-Tompkins, Hampton-Pontiac, and Thetford-Jewell 345-kV lines in Michigan, and the Erie West-Ashtabula-Perry 345-kV line linking the Cleveland area to Pennsylvania. Farther south, the very low voltages on the northern Ohio transmission system made it difficult for the generation in the Cleveland and Lake Erie area to remain synchronous with southeast Michigan. Over the next two minutes, generators in this area shut down after reaching a point of no recovery as the stress level across the remaining ties became excessive.

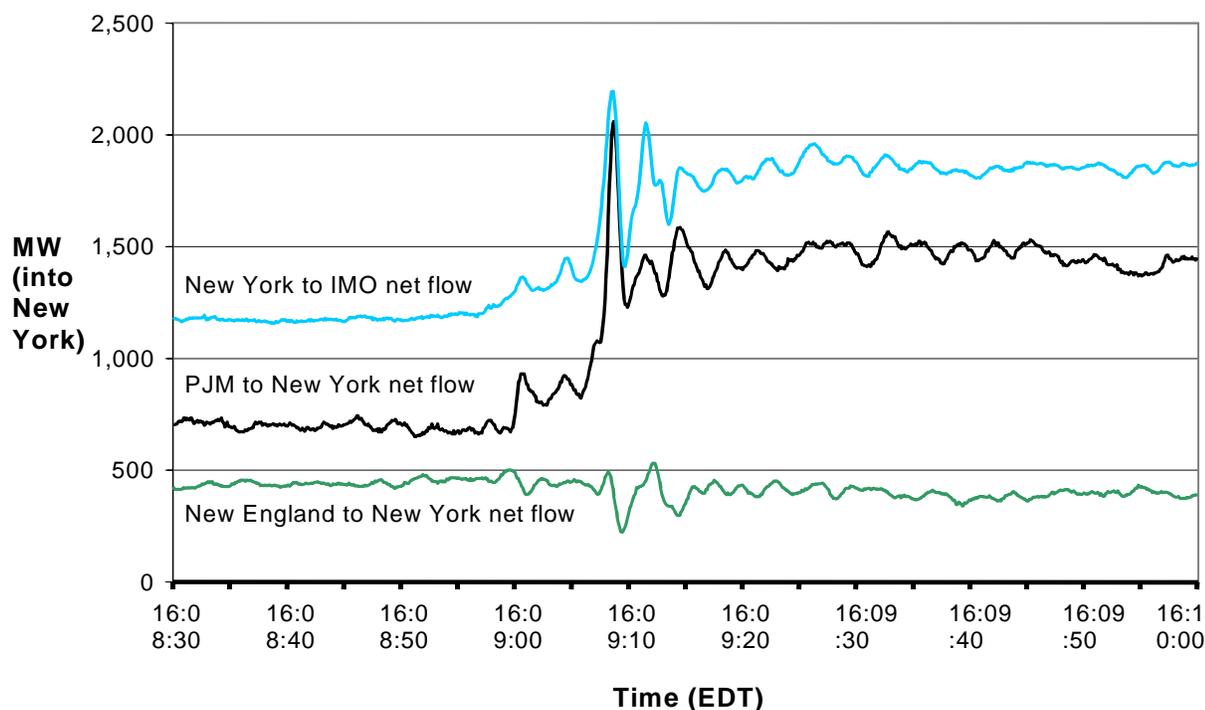
**Figure IV.10 — First Power Swing has Varying Impacts on New York Interfaces**

Figure IV.10, showing metered power flows along the New York interfaces, documents how the flows heading north and west toward Detroit and Cleveland varied at three different New York interfaces. Beginning at 16:09:05, power flows jumped simultaneously across all three interfaces; but when the first power surge peaked at 16:09:09, the change in flow was highest on the PJM interface and lowest on the New England interface. Power flows increased significantly on the PJM-New York and New York-Ontario interfaces because of the redistribution of flow around Lake Erie to serve the loads in northern Ohio and eastern Michigan. The New England and Maritimes systems maintained the same generation-to-load balance and did not carry the redistributed flows because they were not in the direct path of the flows. Therefore, the New England-New York interface flows showed little response.

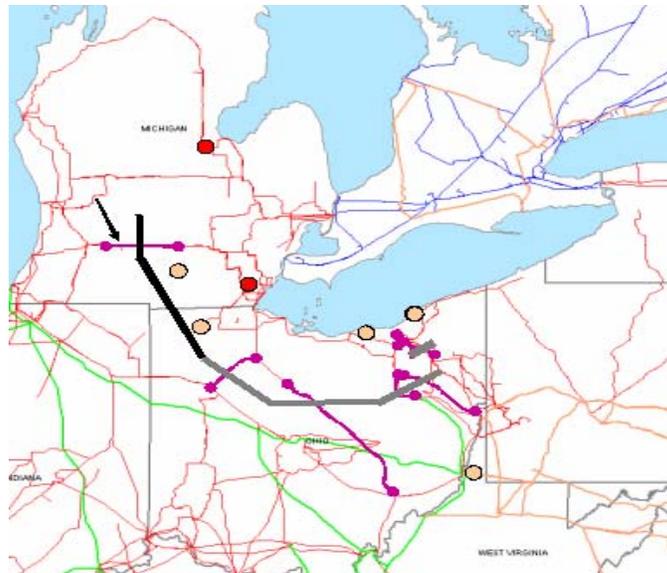
**Figure IV.12 — Transmission and Generation Trips in Eastern Michigan, 16:10:36 to 16:10:37**

Together, the above line outages interrupted the west-to-east transmission paths into the Detroit area from south-central Michigan. The Sumpter generating units tripped in response to under-voltage on the system. Michigan lines west of Detroit then began to trip, as shown in Figure IV.12.

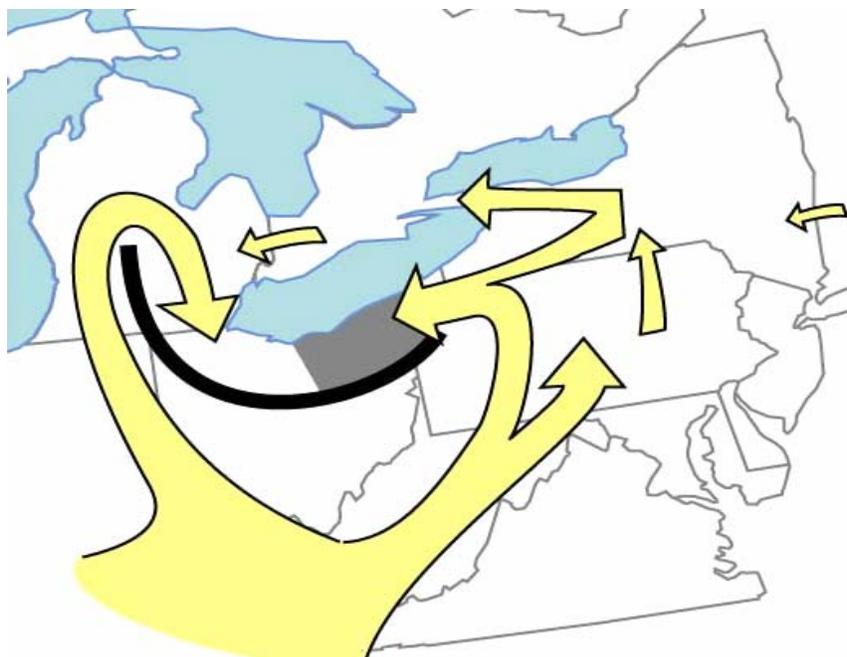
**Figure IV.13 — Power Flows at 16:10:37**

American grid are temporary, automatic reclosing can enhance stability and system reliability. However, situations can occur where the power systems behind the two ends of the line could go out of phase during the high-speed reclose period (typically less than 30 cycles, or one half second, to allow the air to de-ionize after the trip to prevent arc re-ignition). To address this and protect generators from the harm that an out-of-synchronism reconnect could cause, it is worth studying whether a synchro-check relay is needed to reclose only when the two ends of a line are within a certain voltage and phase angle tolerance. No such protection was installed at Argenta-Battle Creek. When the line reclosed, there was a 70 degree difference in phase across the circuit breaker reclosing the line. There is no evidence that the reclose harmed the local generators. Power flows following the trip of the central Michigan lines are shown in Figure IV.13.

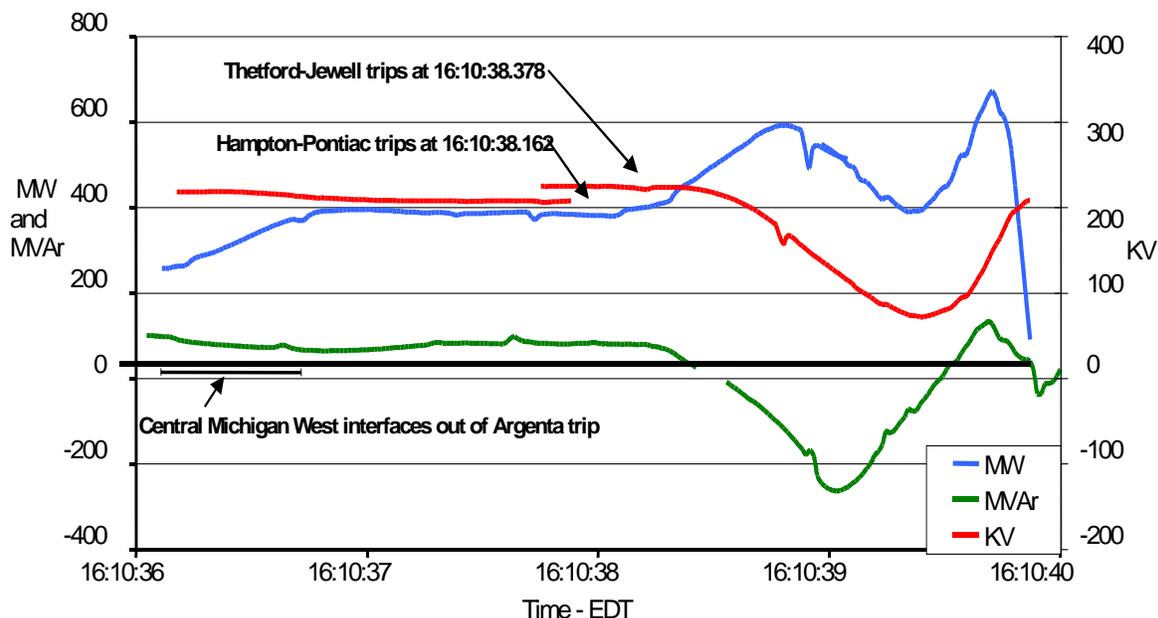
**Figure IV.14 — Flows on Keith-Waterman 230-kV Ontario-Michigan Tie Line**

trigger for a sudden 3,700 MW power surge from Ontario into Michigan. When Thetford-Jewell tripped, power that had been flowing into Michigan and Ohio from western Michigan, western Ohio, and Indiana was cut off. The nearby Ontario recorders saw a pronounced impact as flows into Detroit readjusted to flow in from Ontario instead.

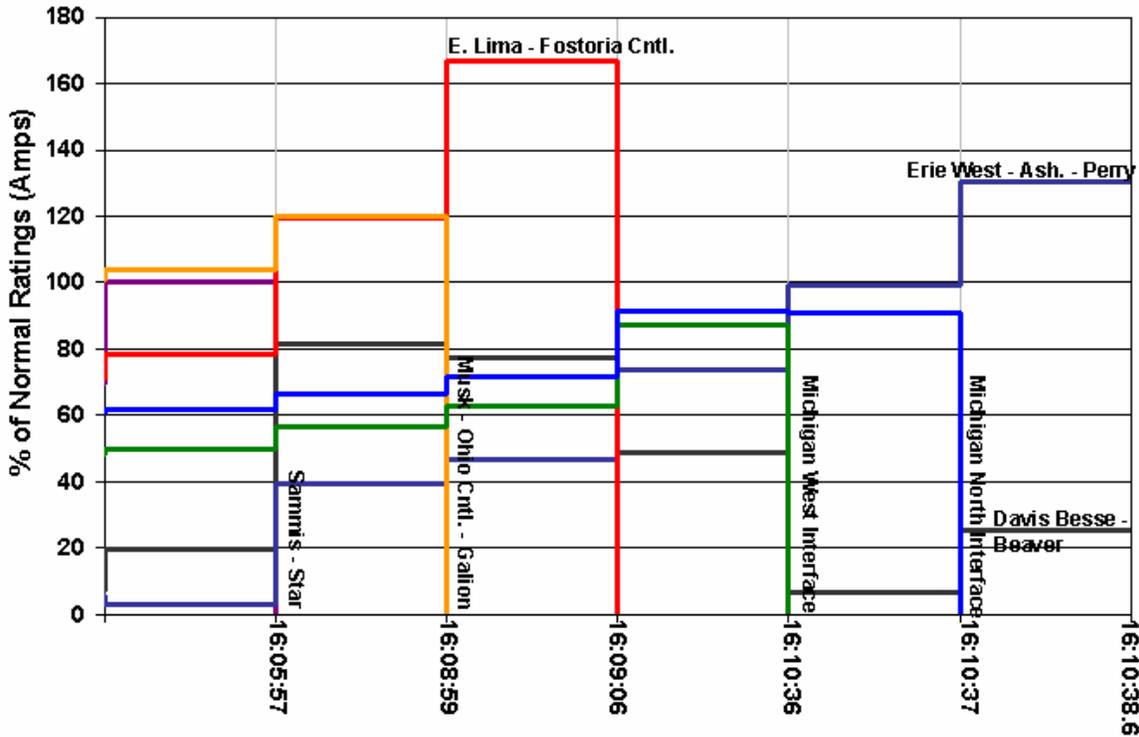
Figure IV.15a — Simulated 345-kV Line Loadings From 16:05:57 Through 16:10:38.6

Figure IV.15a shows the results of modeling of line loadings on the Ohio, Michigan, and other regional interfaces for the period between 16:05:57 until the Thetford-Jewell trip; this helps to illustrate how power flows shifted during this period. Evolving system conditions were modeled for August 14, based on the 16:05:50 power flow case developed by the MAAC-ECAR-NPCC Operations Studies Working Group. Each horizontal line in the graph indicates a single or set of 345-kV lines and their loading as a function of normal ratings over time as first one, then another, set of circuits tripped out of service. In general, each subsequent line trip causes the remaining line loadings to rise. Note that Muskingum and East Lima-Fostoria Central were overloaded before they tripped, but the Michigan west and north interfaces were not overloaded before they tripped. Erie West-Ashtabula-Perry was loaded to 130 percent after the Hampton-Pontiac and Thetford-Jewell trips.

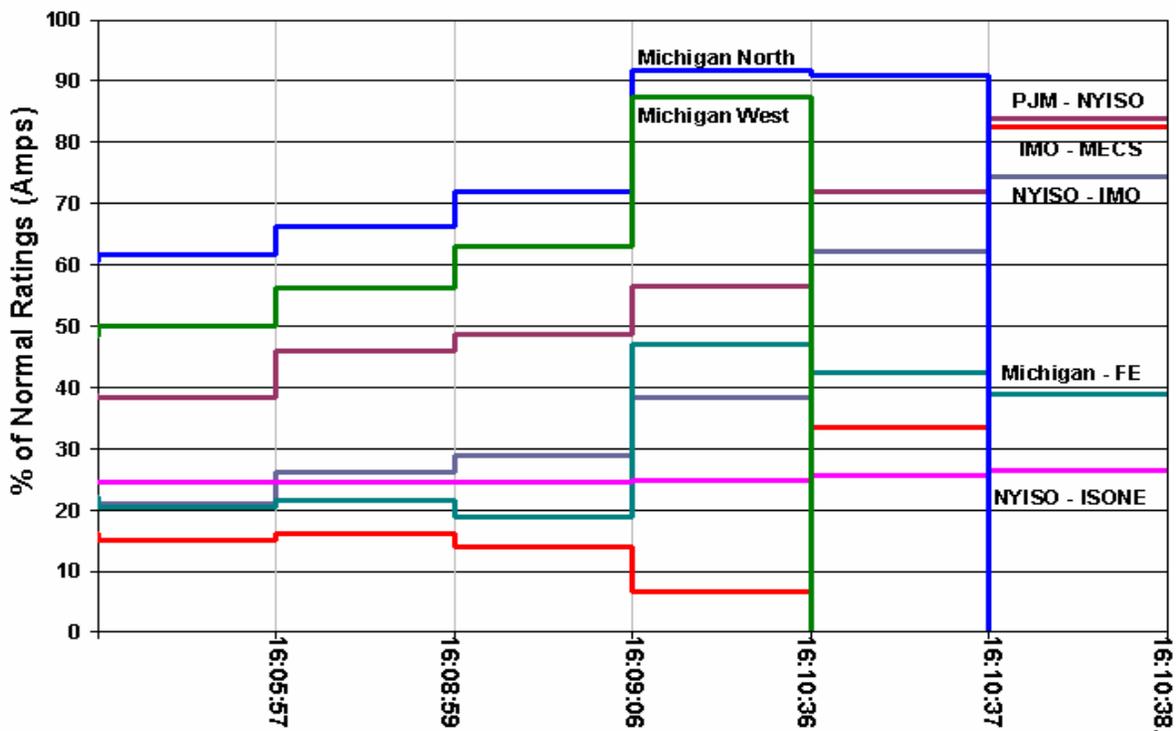
Figure IV.15b — Simulated Regional Interface Loadings From 16:05:57 Through 16:10:38.4

The regional interface loadings graph (Figure VI.15b) shows that loadings at the interfaces between PJM-New York, New York-Ontario, and New York-New England were well within normal ratings before the east-west Michigan separation.

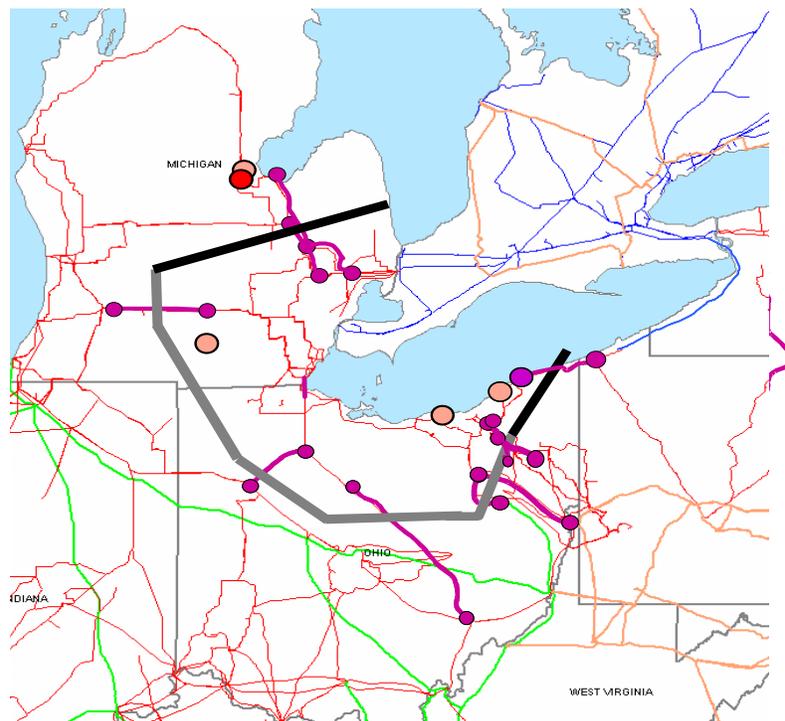
**Figure IV.16 — Michigan Lines Trip and Ohio Separates From Pennsylvania, 16:10:36 to 16:10:38.6**

Perry-Ashtabula was the last 345-kV line connecting northern Ohio to the east along the southern shore of Lake Erie. This line tripped at the Perry substation on a zone 3 relay operation and separated the northern Ohio 345-kV transmission system from Pennsylvania and all 345-kV connections. After this trip, the load centers in eastern Michigan and northern Ohio (Detroit, Cleveland, and Akron) remained connected to the rest of the Eastern Interconnection only to the north of Lake Erie at the interface between the Michigan and Ontario systems (Figure IV.16). Eastern Michigan and northern Ohio now had little internal generation left and voltage was declining. The frequency in the Cleveland area dropped rapidly, and between 16:10:39 and 16:10:50, underfrequency load shedding in the Cleveland area interrupted about 1,750 MW of load. However, the load shedding was not enough to reach a balance with local generation and arrest the frequency decline. The still-heavy loads in Detroit and Cleveland drew power over the only major transmission path remaining: the lines from eastern Michigan east into Ontario.

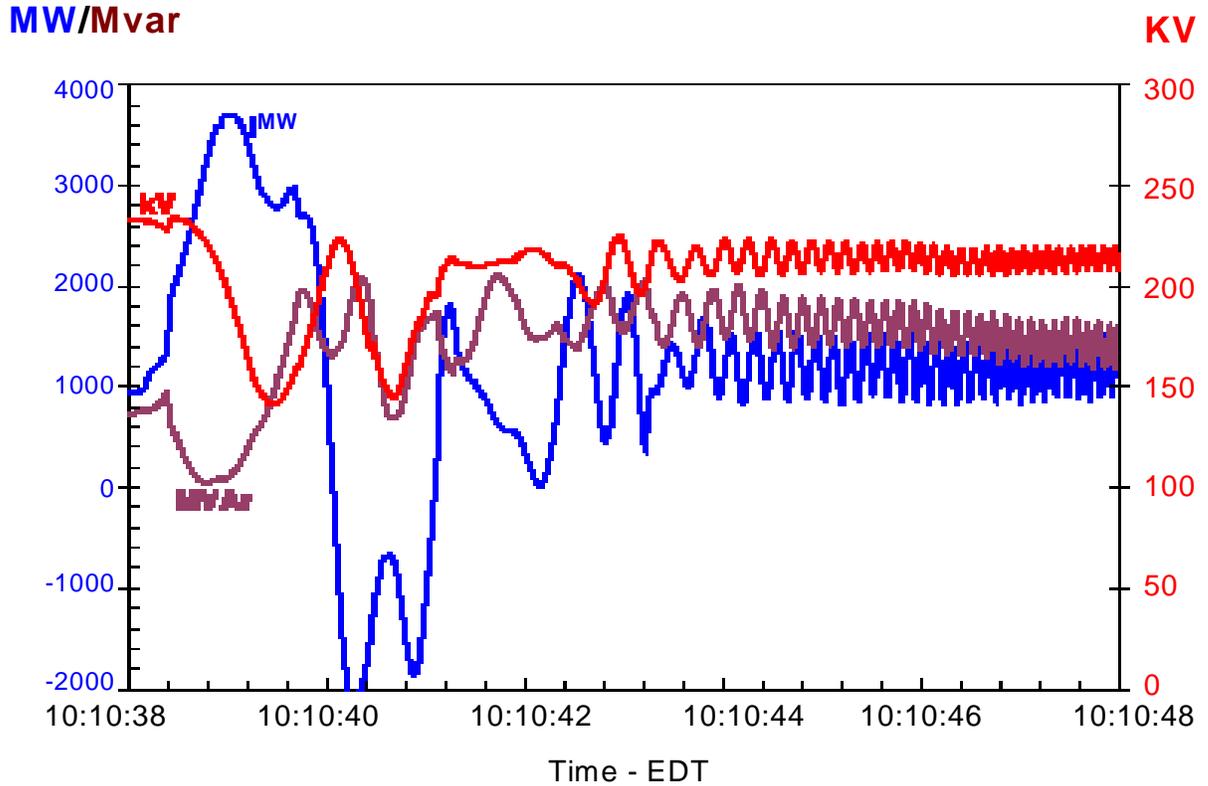
Figure IV.17 — Real and Reactive Power and Voltage From Ontario Into Michigan

At 16:10:38.6, after the 345-kV transmission paths in Michigan and Ohio tripped, the power that had been flowing at modest levels into Michigan from Ontario suddenly jumped in magnitude. While flows from Ontario into Michigan had been in the 250 to 350 MW range since 16:10:09.06, with this new surge the

flows peaked at 3,700 MW at 16:10:39 (Figure IV.17). Electricity moved along a giant loop from the rest of the Eastern Interconnection through Pennsylvania and into New York and Ontario, and then into Michigan via the remaining transmission path to serve the combined loads of Cleveland, Toledo, and Detroit (Figure IV.18). This sudden large change in power flows lowered voltages and increased current levels on the transmission lines along the Pennsylvania-New York transmission interface.

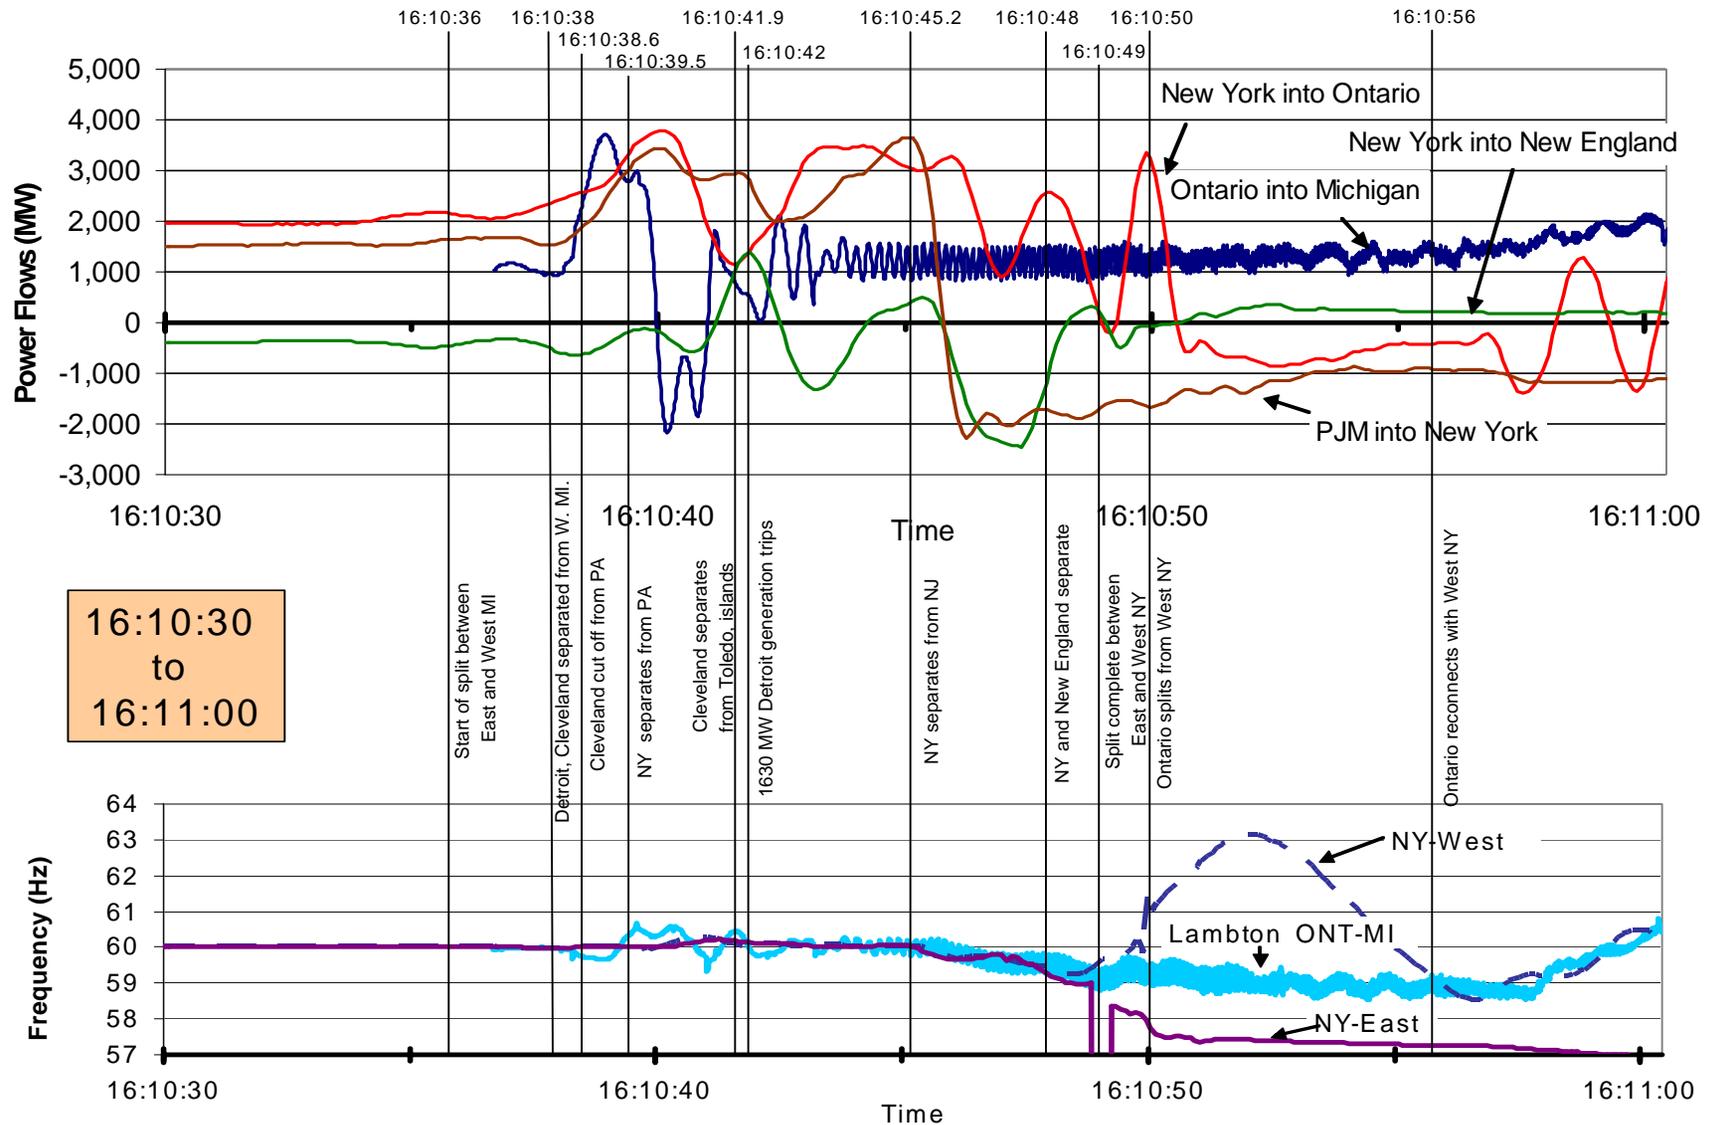
Figure IV.19 — Measured Power Flows and Frequency Across Regional Interfaces, 16:10:30 to 16:11:00, With Key Events in the Cascade

Because the demand for power in Michigan, Ohio, and Ontario was drawing on lines through New York and Pennsylvania, heavy power flows were moving northward from New Jersey over the New York tie lines to meet those power demands, exacerbating the power swing. Figure IV.19 shows actual net line flows summed across the interfaces between the main regions affected by these swings: Ontario into Michigan, New York into Ontario, New York into New England, and PJM into New York. This shows that the power swings did not move in unison across every interface at every moment, but varied in magnitude and direction. This occurred for two reasons. First, the availability of lines across each interface varied over time, as did the amount of load that drew upon each interface, so net flows across each interface were not facing consistent demand with consistent capability as the cascade progressed. Second, the speed and magnitude of the swing was moderated by the inertia, reactive power capabilities, loading conditions, and locations of the generators across the entire region.

After Cleveland was cut off from Pennsylvania and eastern power sources, Figure IV.19 also shows the start of the dynamic power swing at 16:10:38.6. Because the loads of Cleveland, Toledo, and Detroit (less the load already blacked out) were now served through Michigan and Ontario, this forced a large shift in power flows to meet that demand. As noted above, flows from Ontario into Michigan increased from 1,000 MW to a peak of 3,700 MW shortly after the start of the swing, while flows from PJM into New York were close behind (Figure IV.20). But within one second after the peak of the swing, at 16:10:40, flows reversed and flowed back from Michigan into Ontario at the same time that frequency at the interface dropped (Figure IV.21). The large load and imports into northern Ohio were losing synchronism with southeastern Michigan. Flows that had been westbound across the Ontario-Michigan interface by more than 3,700 MW at 16:10:38.8 reversed to 2,100 MW eastbound by 16:10:40, and then returned westbound starting at 16:10:40.5.

Re-examination of Figure IV.19 shows the power swing from the northeast through Ontario into Michigan and northern Ohio that began at 16:10:37, and how it reverses and swings back around Lake Erie at 16:10:39. That return was caused by the combination of natural oscillation accelerated by major load losses, as the northern Ohio system disconnected from Michigan. It caused a power flow change of 5,800 MW, from 3,700 MW westbound to 2,100 eastbound across the Ontario-to-Michigan border between 16:10:39.5 and 16:10:40. Since the system was now fully dynamic, this large oscillation eastbound would lead naturally to a rebound, which began at 16:10:40 with an inflection point reflecting generation shifts between Michigan and Ontario and additional line losses in Michigan.

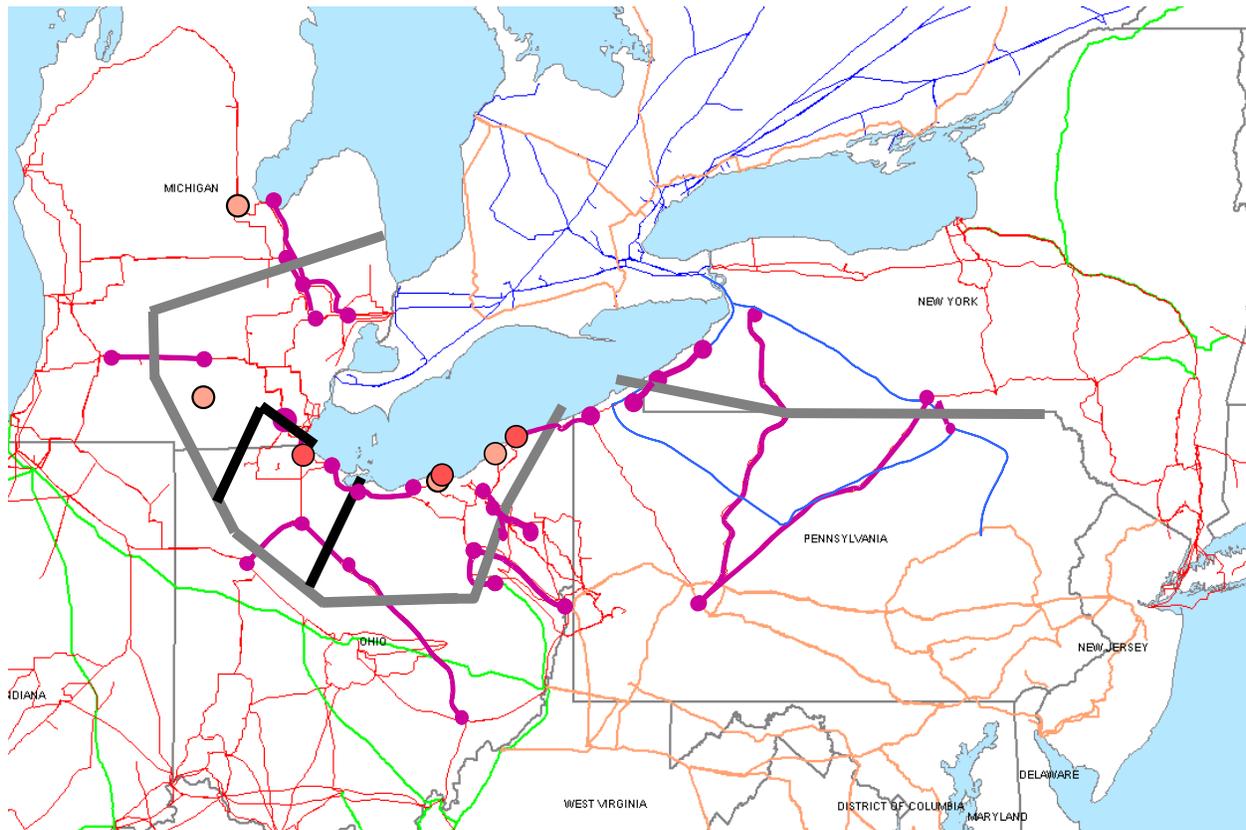
**Figure IV.22 — Cleveland and Toledo Islanded, 16:10:39 to 16:10:46**

In northern Ohio, the trips of the Bay Shore-Monroe, Majestic-Lemoyne, Allen Junction-Majestic-Monroe 345-kV lines, and the Ashtabula 345/138-kV transformer cut off Toledo and Cleveland from the north, turning that area into an electrical island (Figure IV.22). After these 345-kV line trips, the high power imports from southeastern Michigan into Ohio suddenly stopped at 16:10:40. Frequency in this island began to fall rapidly. This caused a series of power plants in the area to trip off-line due to the operation of underfrequency relays, including the Bay Shore units. Cleveland area load was disconnected by automatic underfrequency load shedding (approximately 1,300 MW), and another 434 MW of load

was interrupted after the generation remaining within this transmission island was tripped by underfrequency relays. This sudden load drop would contribute to the reverse power swing described previously. In its own island, portions of Toledo blacked out from automatic underfrequency load shedding but most of the Toledo load was restored by automatic reclosing of lines such as the East Lima-Fostoria Central 345-kV line and several lines at the Majestic 345-kV substation.

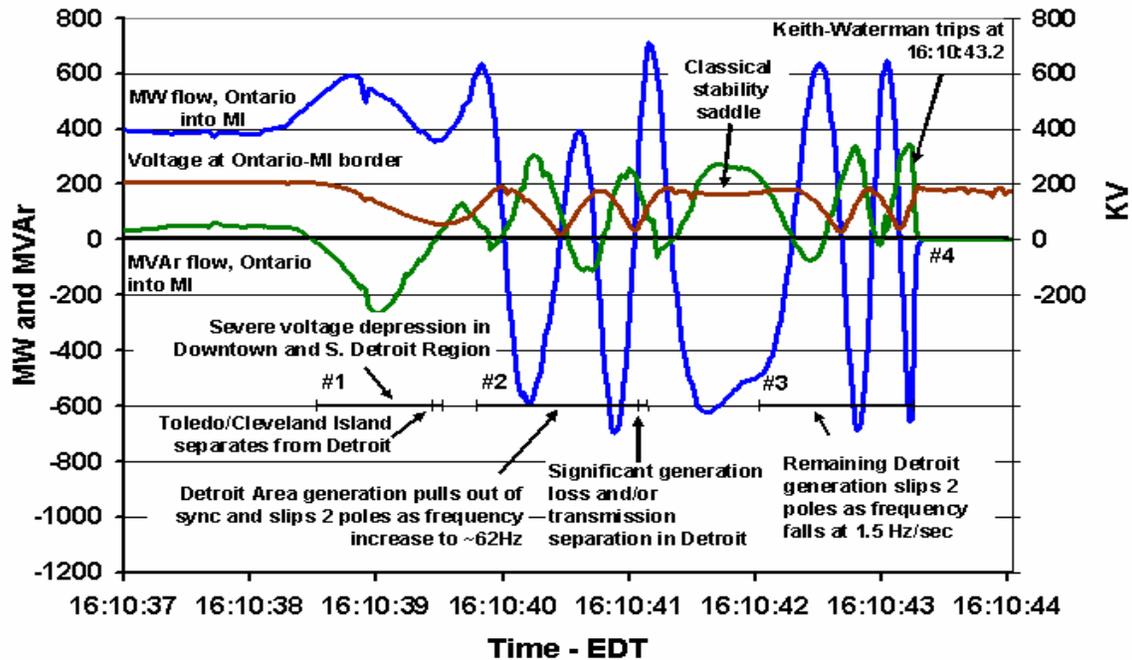
**Figure IV.23 — Generators Under Stress in Detroit, as Seen From Keith PSDR**

The large power surge into Michigan, beginning at 16:10:38, occurred when Toledo and Cleveland were still connected to the grid through Detroit. After the Bayshore-Monroe line tripped at 16:10:39, Toledo and Cleveland separated into their own island, dropping a large amount of load off of the Detroit system. This suddenly left Detroit with excess generation, much of which greatly accelerated in angle as the depressed voltage in Detroit (caused by the high demand in Cleveland) caused the Detroit units to begin to pull out of step with the rest of the grid. When voltage in Detroit returned to near-normal, the generators could not sufficiently decelerate to remain synchronous. This out-of-step condition is evident in Figure IV.23, which shows at least two sets of generator “pole slips” by plants in the Detroit area

between 16:10:40 and 16:10:42. Several large units around Detroit: Belle River, St. Clair, Greenwood, Monroe, and Fermi Nuclear all tripped in response. After the Cleveland-Toledo island formed at 16:10:40, Detroit frequency spiked to almost 61.7 Hz before dropping, momentarily equalized between the Detroit and Ontario systems. But Detroit frequency then began to decay at 2 Hz/sec and the generators experienced under-speed conditions.

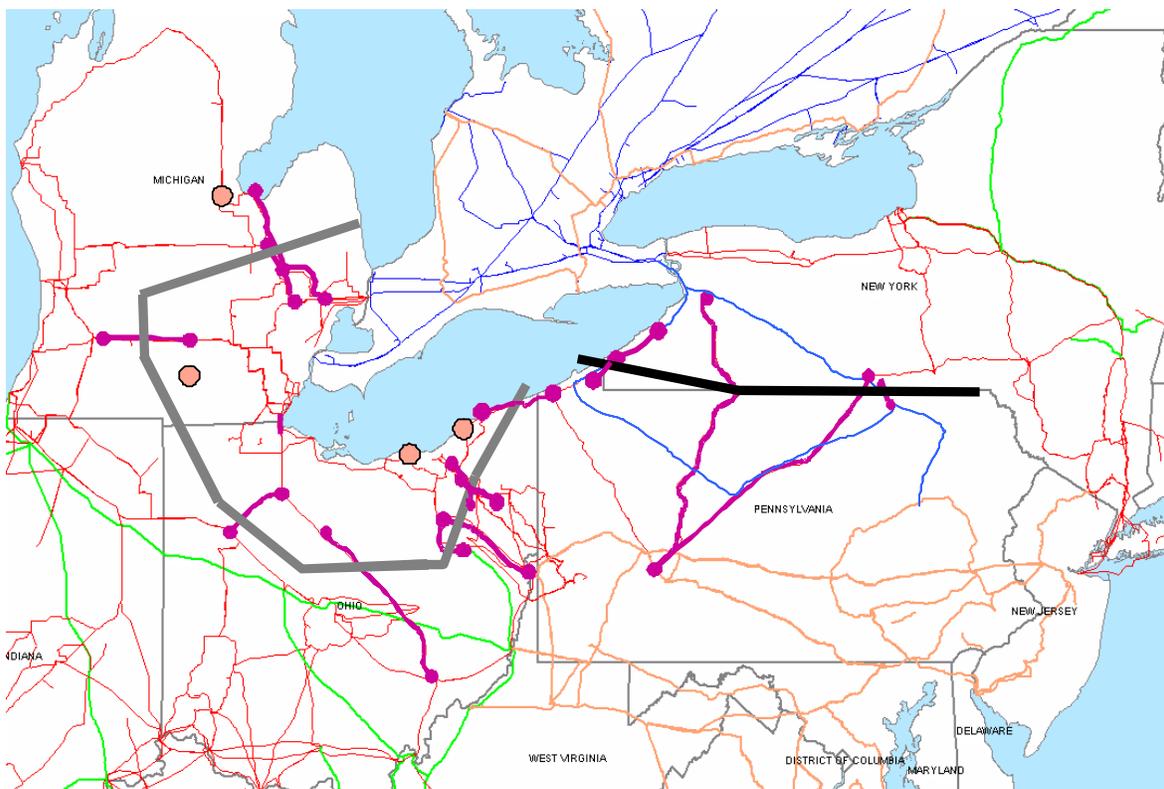
**Figure IV.24 — Western Pennsylvania Separates From New York,  
16:10:39 to 16:10:44**

Watercure (177 miles) and Homer City-Stolle Road (207 miles) are relatively long lines with high impedances. Zone 1 relays do not have timers, and therefore operate nearly instantly when a power swing enters the relay target circle. For normal length lines, zone 1 relays have smaller target circles because the relay is measuring less than the full length of the line, but for a long line the greater impedance enlarges the relay target circle and makes it more likely to be hit by the power swing. The Homer City-Watercure and Homer City-Stolle Road lines do not have zone 3 relays.

Given the length and impedance of these lines, it was highly likely that they would trip and separate in the face of such large power swings. Most of the other interfaces between regions have shorter ties. For instance, the ties between New York and Ontario and Ontario to Michigan are only about two miles long, so they are electrically very short and thus have much lower impedance and trip less easily than these long lines. A zone 1 relay target on a short line covers a small distance so a power swing is less likely to enter the relay target circle at all, averting a zone 1 trip.
