# Systems Failure Anatomy of a Blackout

Course# EE420

**Technical Analysis of the  
August 14, 2003, Blackout:  
*What Happened, Why, and What Did We Learn?***

**Report to the NERC Board of Trustees  
by the NERC Steering Group**

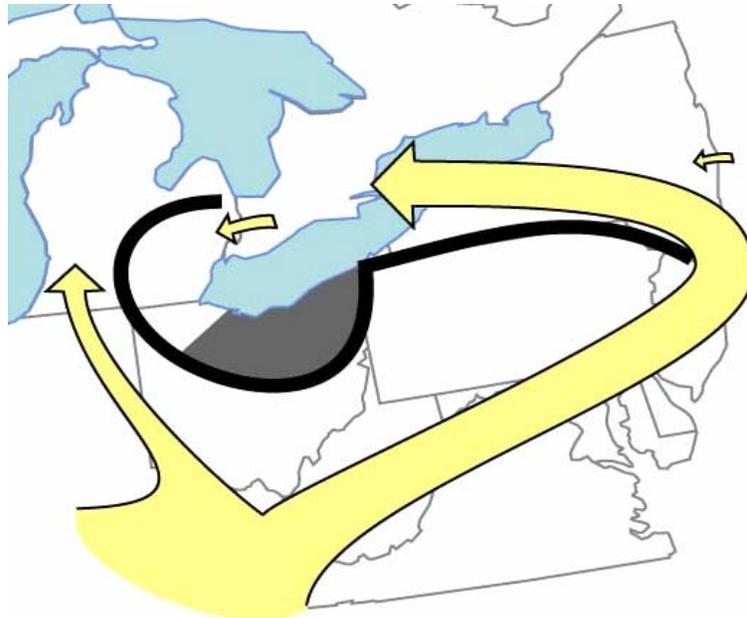
Figure IV.25 — Power Flows at 16:10:44

At 16:10:44, (see Figure IV.25) the northern part of the Eastern Interconnection (including eastern Michigan) was connected to the rest of the Interconnection at only two locations: (1) in the east through the 500-kV and 230-kV ties between New York and northeastern New Jersey, and (2) in the west through the long and electrically fragile 230-kV transmission path connecting Ontario to Manitoba and Minnesota. The separation of New York from Pennsylvania (leaving only the lines from New Jersey into New York connecting PJM to the northeast) helped to buffer PJM in part from these swings. Frequency was high in Ontario at that point, indicating that there was more generation than load, so much of this flow reversal never got past Ontario into New York.

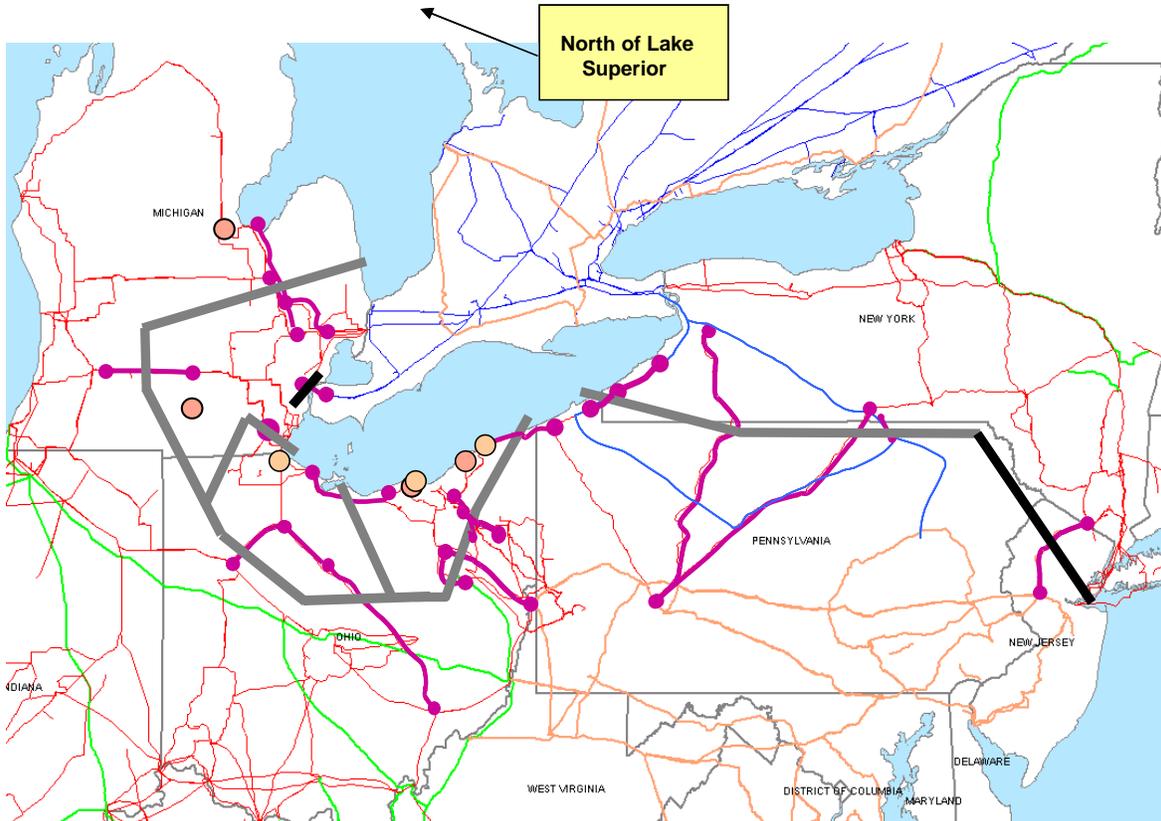
**Figure IV.26 — Northeast Separates From Eastern Interconnection, 16:10:45**

At 16:10:45, northwest Ontario separated from the rest of Ontario when the Wawa-Marathon 230-kV lines (168 km long) disconnected along the northern shore of Lake Superior, tripped by zone 1 distance relays at both ends. This separation left the loads in the far northwest portion of Ontario connected to the Manitoba and Minnesota systems, and protected them from the blackout (Figure IV.26).

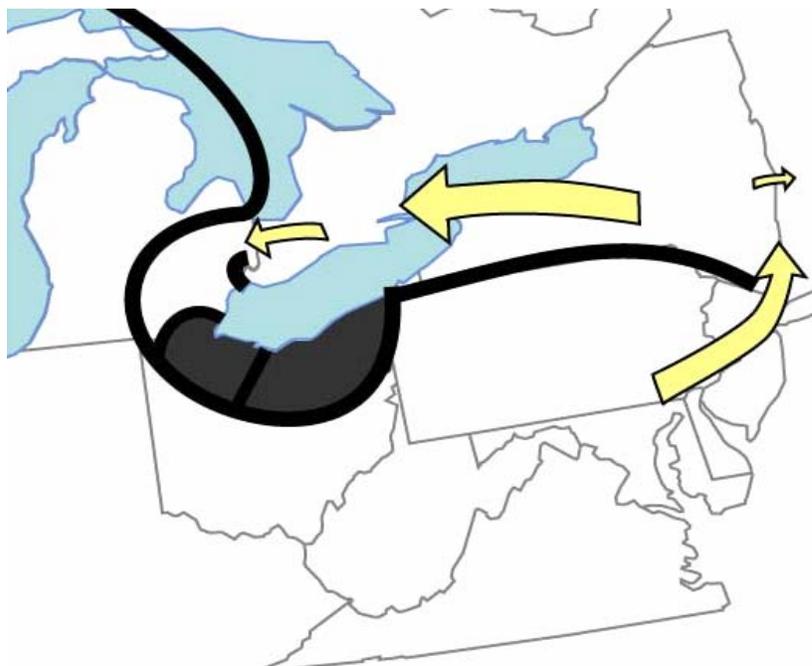
**Figure IV.27 — Power Flows at 16:10:45**

As shown in Figure IV.27, the 69-mile long Branchburg-Ramapo line and Ramapo transformer between New Jersey and New York was the last major transmission path remaining between the Eastern Interconnection and the area ultimately affected by the blackout. Figure IV.28 shows how that line disconnected at 16:10:45, along with other underlying 230 and 138-kV lines in northeastern New Jersey. Branchburg-Ramapo was carrying over 3,000 MVA and 4,500 amps with voltage at 79 percent before it tripped, either on a high-speed swing into zone 1 or on a direct transfer trip. The investigation team is still examining why the higher impedance 230-kV overhead lines tripped while the underground Hudson-Farragut 230-kV cables did not; the available data suggest that the lower impedance of underground cables made these less vulnerable to the electrical strain placed on the system.

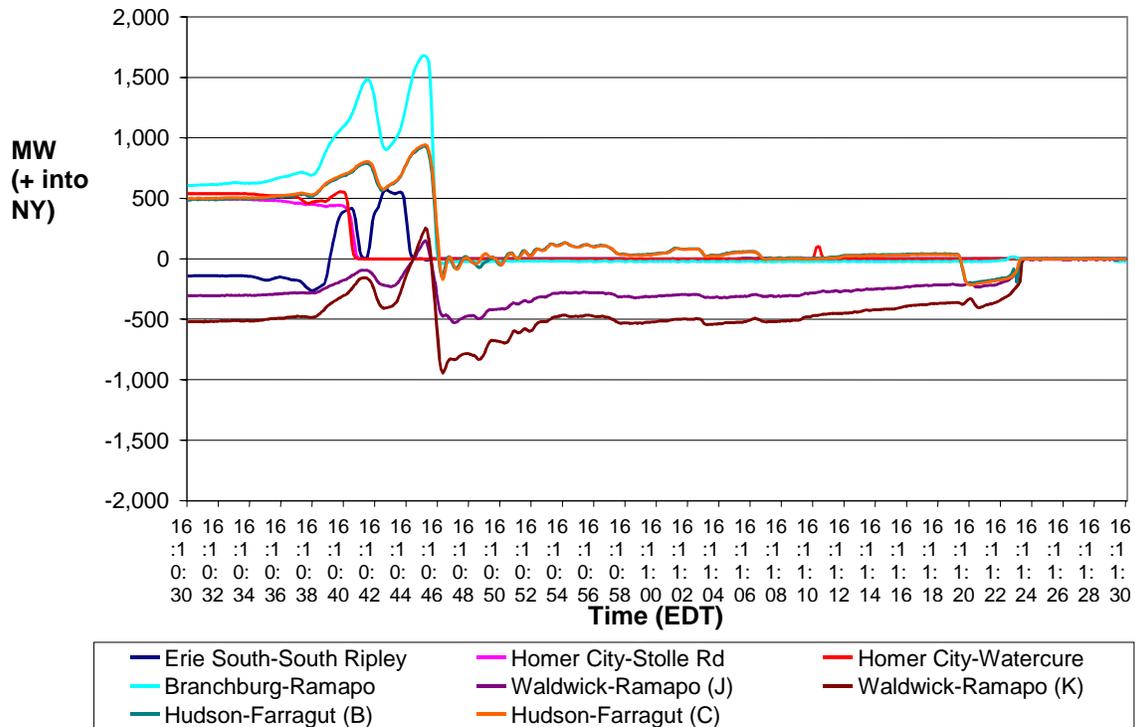
**Figure IV.28 — PJM to New York Ties Disconnect**

This left the northeast portion of New Jersey connected to New York, while Pennsylvania and the rest of New Jersey remained connected to the rest of the Eastern Interconnection. Within northeastern New Jersey, the separation occurred along the 230-kV corridors, which are the main supply feeds into the northern New Jersey area (the two Roseland-Athenia circuits and the Linden-Bayway circuit). These circuits supply the large customer load in northern New Jersey and are a primary route for power transfers into New York City, so they are usually more highly loaded than other interfaces. These lines tripped west and south of the large customer loads in northeast New Jersey.

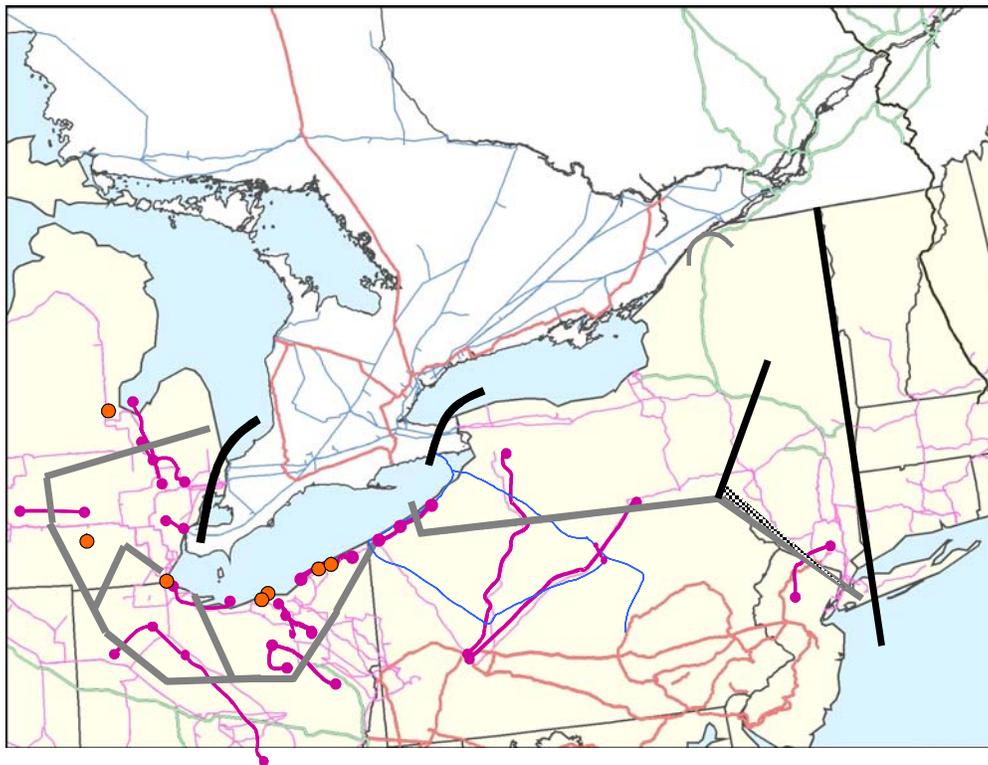
**Figure IV.29 — New York and New England Separate, Multiple Islands Form**

- New York-New England upstate transmission lines disconnected: 16:10:46 to 16:10:47
- New York transmission system split along Total East interface: 16:10:49
- The Ontario system just west of Niagara Falls and west of St. Lawrence separated from the western New York island: 16:10:50

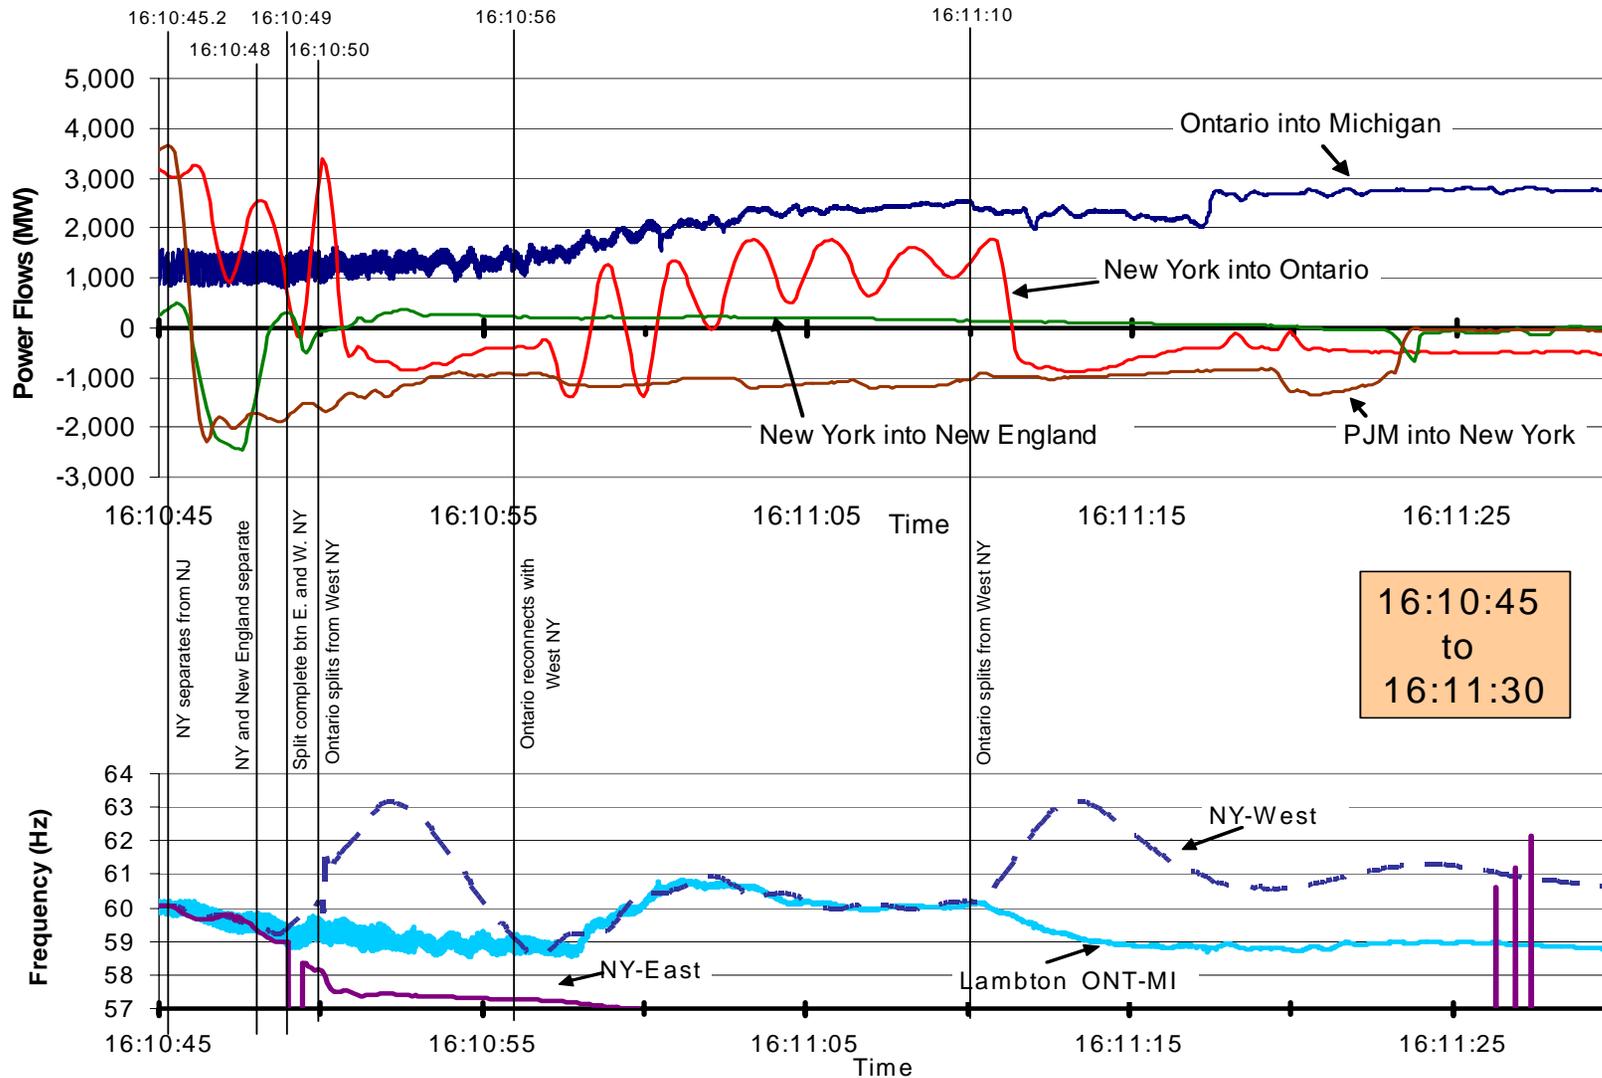
Figure IV.30 — Measured Power Flows and Frequency Across Regional Interfaces, 16:10:45 to 16:11:30, With Key Events in the Cascade

The entire northeastern system was experiencing large scale, dynamic oscillations during this period. Even if the UFLS and generation had been perfectly balanced at any moment in time, these oscillations would have made stabilization difficult and unlikely. Figure IV.30 gives an overview of the power flows and frequencies during the period 16:10:45 through 16:11:00, capturing most of the key events in the final phase of the cascade.

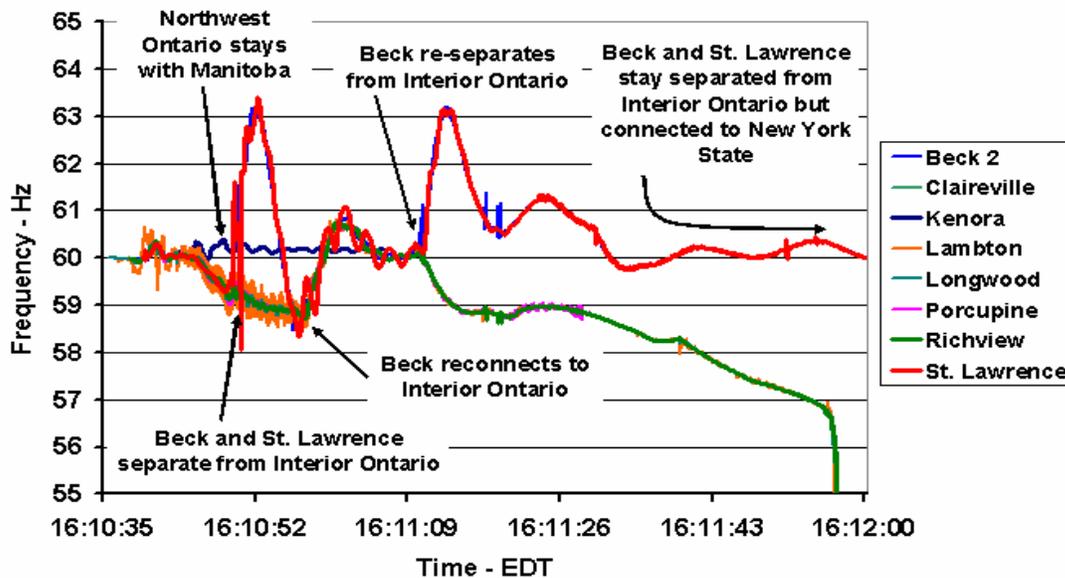
**Figure IV.31 — Separation of Ontario and Western New York**

The Ontario system separated from the western New York island just west of Niagara Falls and west of St. Lawrence at 16:10:50. This separation was due to relay operations that disconnected nine 230-kV lines within Ontario. These left most of Ontario isolated. Ontario's large Beck and Saunders hydro stations, along with some Ontario load, the NYPA Niagara and St. Lawrence hydro stations, and NYPA's 765-kV AC interconnection to their HVDC tie with Québec, remained connected to the western New York system, supporting the demand in upstate New York. From 16:10:49 to 16:10:50, frequency in Ontario declined below 59.3 Hz, initiating automatic UFLS (3,000 MW). This load shedding dropped about 12 percent of Ontario's remaining load. Between 16:10:50 and 16:10:56, the isolation of Ontario's 2,300 MW Beck and Saunders hydro units onto the western New York island, coupled with UFLS, caused the frequency in this island to rise to 63.4 Hz due to excess generation relative to the load remaining within the island. This is shown in Figure VI.31. The high frequency caused trips of five of the U.S. nuclear units within the island, and the last one tripped on the second frequency rise.

Three of the 230-kV transmission circuits reclosed near Niagara automatically to reconnect Ontario to New York at 16:10:56. Even with these lines reconnected, the main Ontario island (still attached to New York and eastern Michigan) was extremely deficient in generation, so its frequency declined towards 58.8 Hz, the threshold for the second stage of UFLS. Over the next two seconds, another 19 percent of Ontario demand (4,800 MW) automatically disconnected by UFLS. At 16:11:10, these same three lines tripped a second time west of Niagara, and New York and most of Ontario separated for a final time. Following this separation, the frequency in Ontario declined to 56 Hz by 16:11:57. With Ontario still supplying 2,500 MW to the Michigan-Ohio load pocket, the remaining ties with Michigan tripped at 16:11:57. Ontario system frequency declined, leading to a widespread shutdown at 16:11:58 and a loss of 22,500 MW of load in Ontario, including the cities of Toronto, Hamilton, and Ottawa.

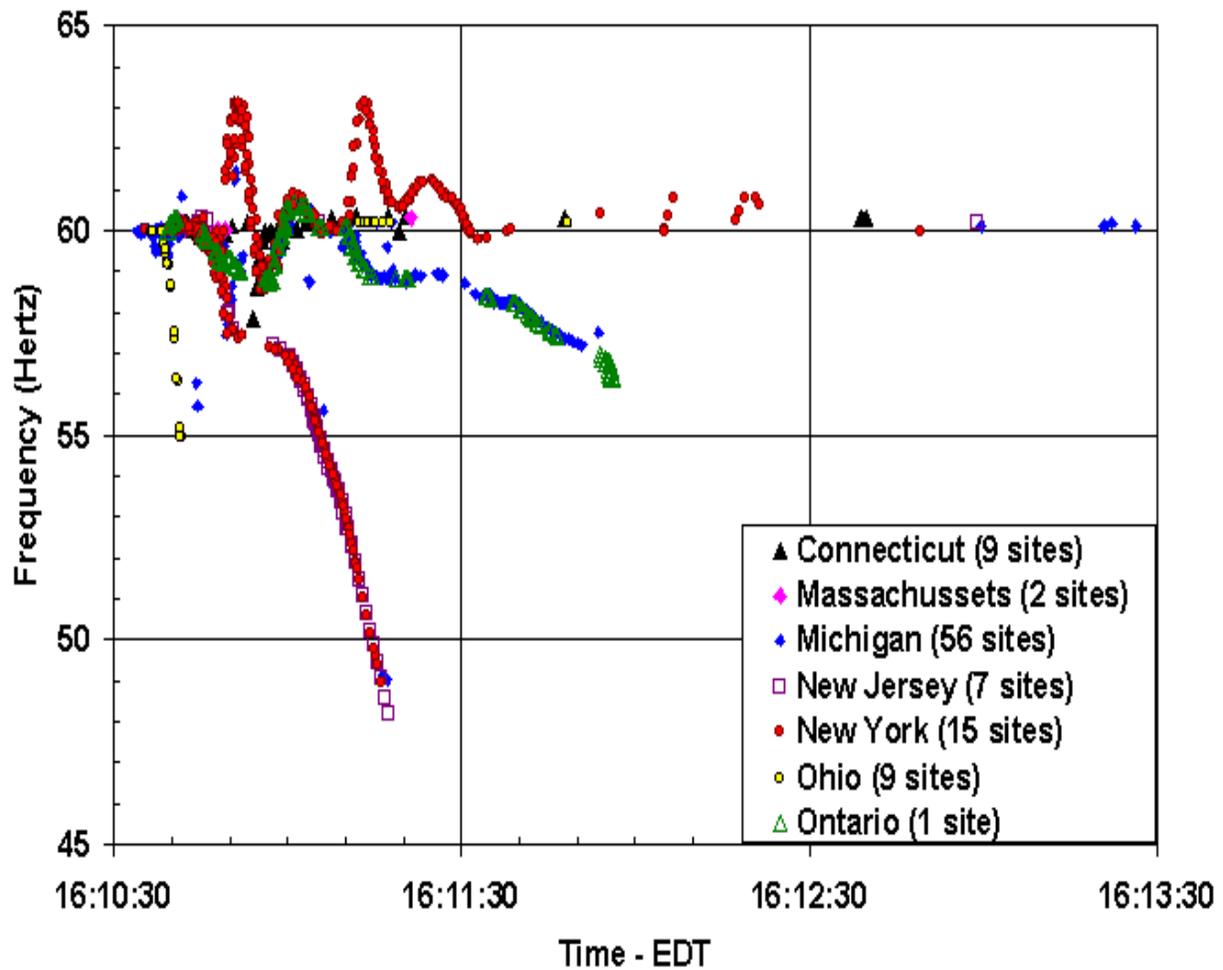
Figure IV.32 — Electric Islands Reflected in Frequency Plot

Figure IV.32 shows frequency data collected by the distribution-level monitors of Softswitching Technologies, Inc. (a commercial power quality company serving industrial customers) for the area affected by the blackout. The data reveal at least five separate electrical islands in the Northeast as the cascade progressed. The two paths of red circles on the frequency scale reflect the Albany area island (upper path) versus the New York City island, which declined and blacked out much earlier.

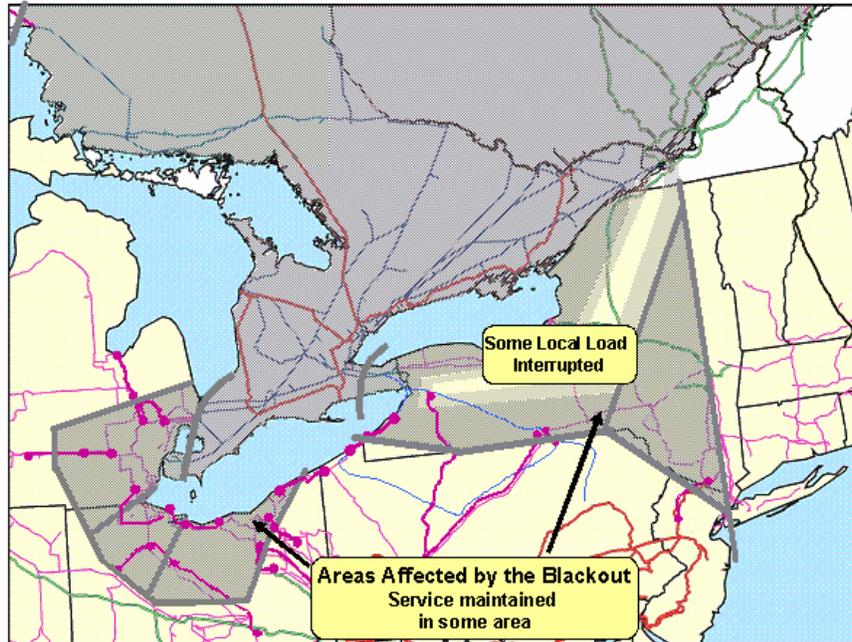
**Figure IV.33 — Areas Affected by the Blackout**

Most of the Northeast (the area shown in gray in Figure VI.33) had now blacked out. Some isolated areas of generation and load remained on-line for several minutes. Some of those areas in which a close generation-demand balance could be maintained remained operational.

One relatively large island remained in operation, serving about 5,700 MW of demand, mostly in western New York. Ontario's large Beck and Saunders hydro stations, along with some Ontario load, the NYPA Niagara and St. Lawrence hydro stations, and NYPA's 765-kV AC interconnection with Québec, remained connected to the western New York system, supporting demand in upstate New York. This island formed the basis for restoration in both New York and Ontario.

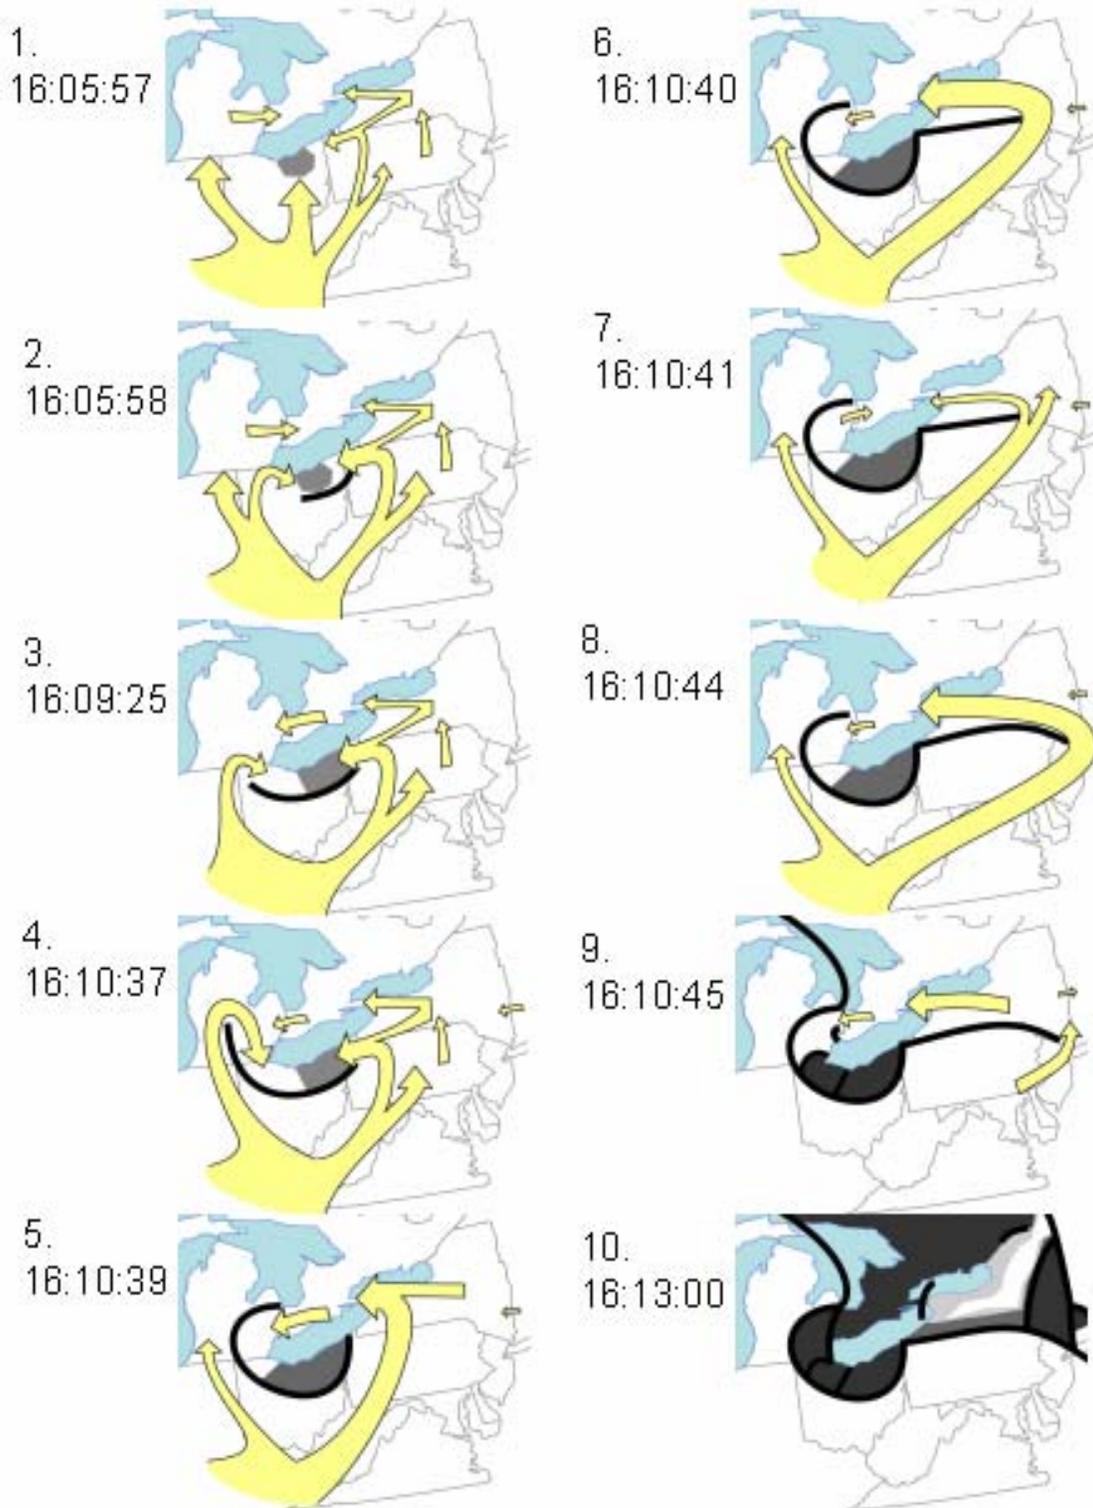
Figure IV.34 — Cascade Sequence Summary

The entire cascade sequence is summarized graphically in figure VI.34.
